CONSTGLASS

Table of results

CAN SXXVIII A16

**Identification of the panel:** SXXVIII CAN A16

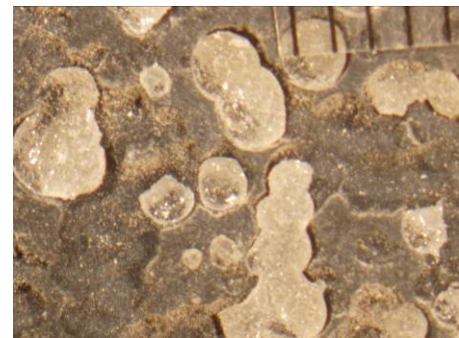
Image under optical microscope in reflected light

An opaque coating inside the pitting only. Slightly lifting out of the pitting.

Serious deterioration of the film: flakes of coating remain in corrosion pits only; the coating shows discolouration (slight yellowing) and loss of transparency. A higher magnification indicates the coating has not taken off the gel layer.

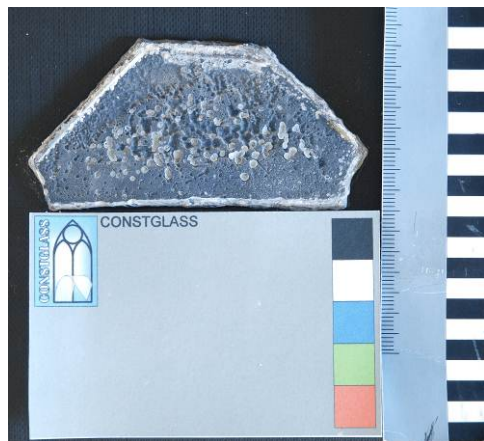
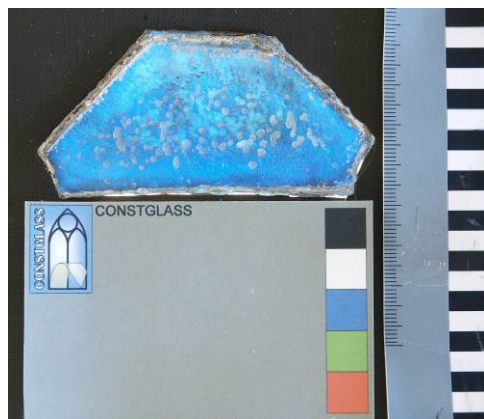
Selected glass piece in reflected and transmitted light

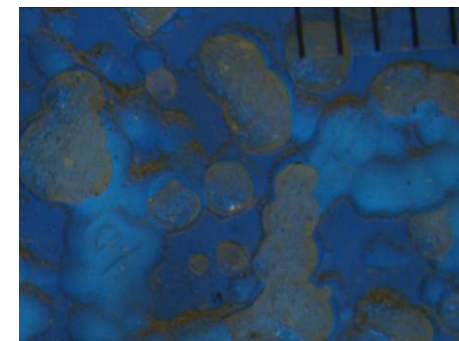
Image under optical microscope in transmitted light
