**CONSTGLASS**

Table of results

*The Typological Passion*, CHARTRES  
Bay 37, panel 16

**Sample reference:** *CHA\_b37p16\_I\_v2 : white glass, coated on internal surface (consolidation)*

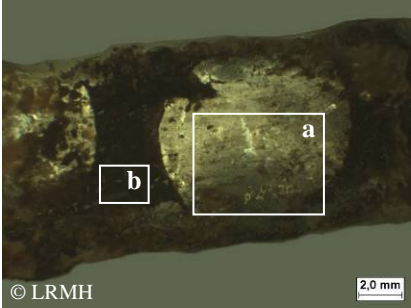
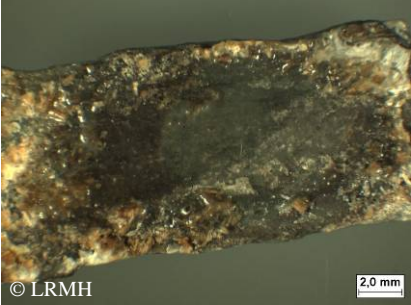
<p>© LRMH</p> <p><i>White rectangles locate the optical microscope observations</i></p>	<p><b>Optical Microscope</b></p>	<p>No visible deterioration except scratches (provenance unknown), no macro-cracks, no yellowing or milky aspect.</p> <p>But, with a higher magnification, micro-cracks are visible.</p> <p><i>White rectangle locates the area of SEM observations.</i></p>

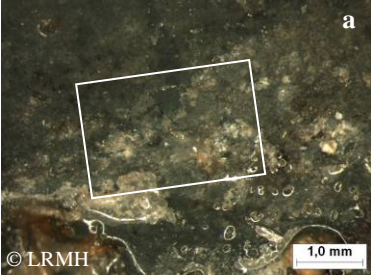
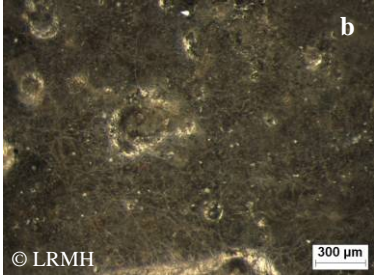
<p>© LRMH</p> <p>a - scratch on the Viacryl®, and apparition of glass b - micro-cracks on the coating</p>
	<p><b>SEM</b></p>	<p>The SEM confirms the microscope observations. There is no macro-cracks (b), except the scratch (a).</p>

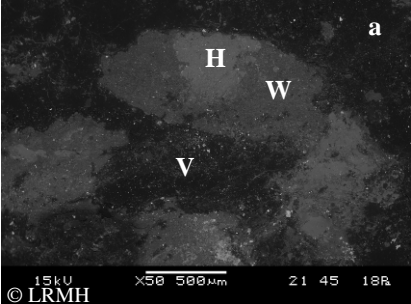
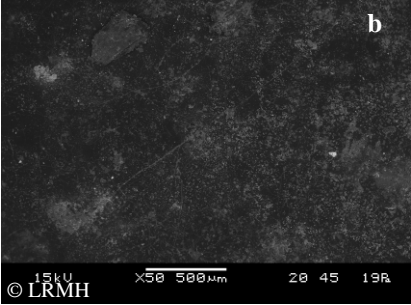
<p>© LRMH</p> <p>a - detail of the scratch: healthy (H) and weathered (W) glass appearing under damaged Viacryl® (V).</p> <p>b - micro-cracks on the coating, with gypsum inside (and on the surface of Viacryl®).</p>

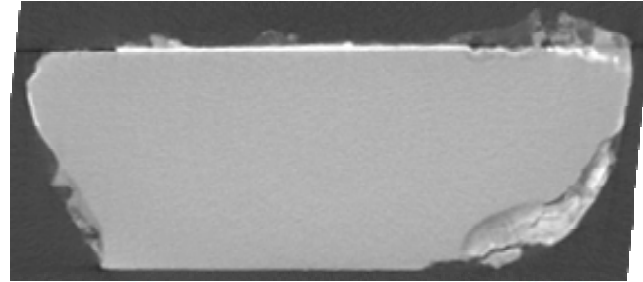
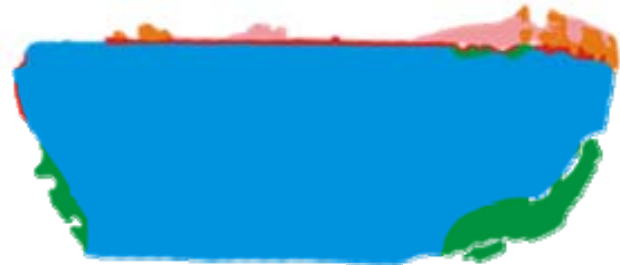
Slice of the piece of glass with Viacryl® coating on the grisaille, and remains of putty.

Application of Viacryl® is not smooth, its thickness is varying.

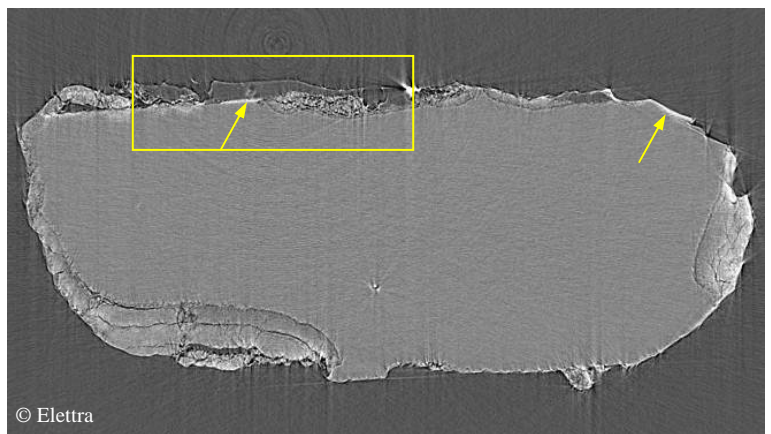
Other slice of the piece of glass (dense grey) with some grisaille (arrows), the rectangle locates the detailed view below.

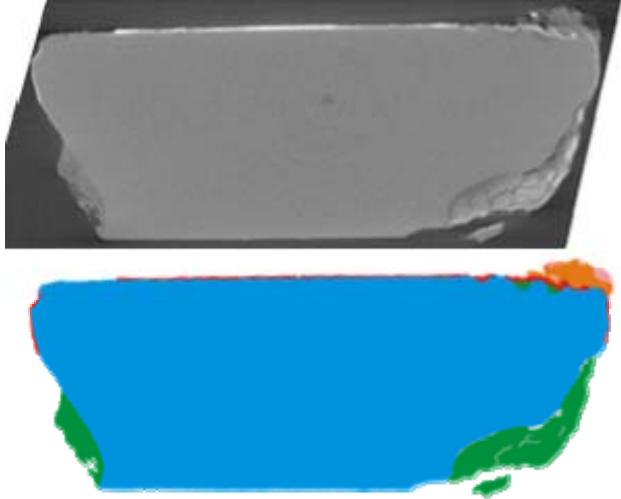
<p>Observation with tomography allows to see the efficiency of the cleaning: no Viacryl® polymer remains (except on the putty) and the grisaille seems not to be damaged. But this technique did not give information about the re-treatment: the layers of ORMOCER® are very thin, because of the dilution of the polymer for the application.</p>

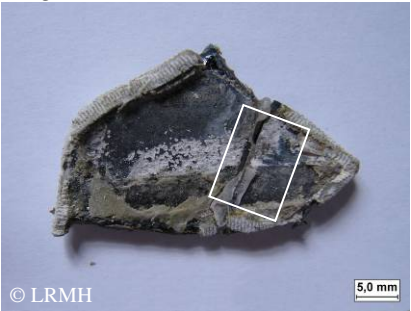
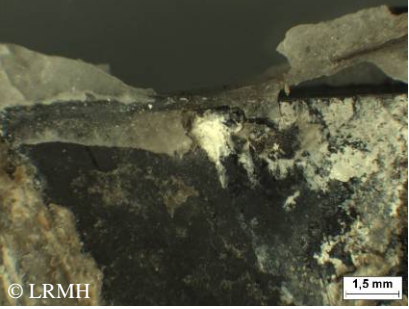
<p>© LRMH</p>	<p>No visible deterioration, no macro-cracks, no yellowing or milky aspect, still smooth.</p> <p>There is a rest of bonding between silicone and the edge of the glass piece.</p> <p><i>White rectangle locates the area of tomography slices.</i></p>
	<p><b>SEM</b></p>	<p>This technique doesn't give answers about morphology or bonding.</p>
	<p><b>Desktop tomography</b></p>	<p><i>Not foreseen</i></p>
	<p><b>Phase-contrast tomography on Synchrotron</b></p>

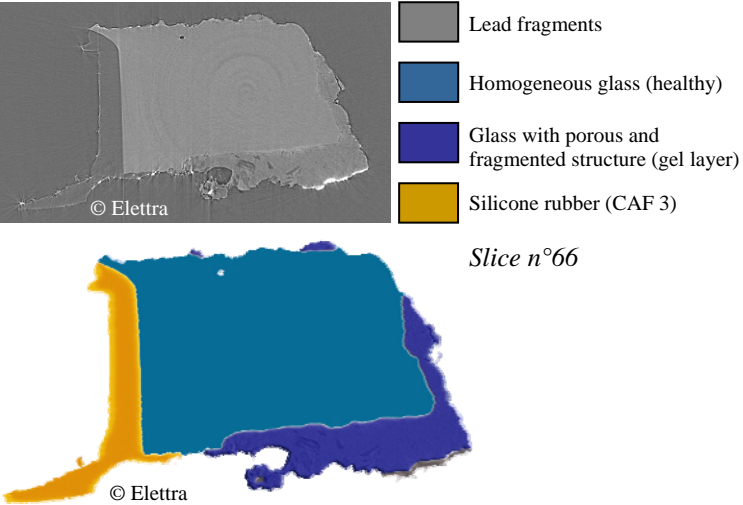
<p>© Elettra</p> <p><i>Slice n°66</i></p> <p>© Elettra</p> <p>The Silicone takes the shape of the glass surface. The adherence is good with the edges of the glass.</p>

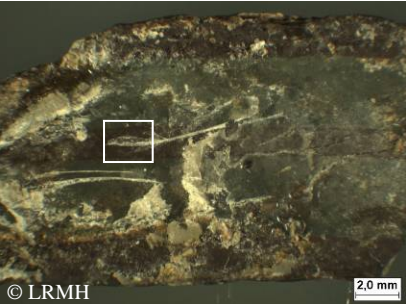
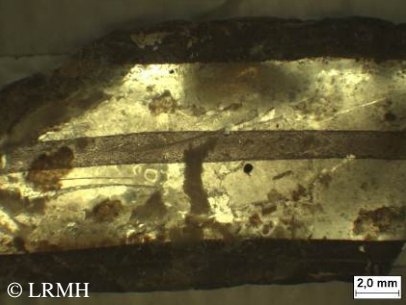
<p>© LRMH 2,0 mm</p> <p>© LRMH 2,0 mm</p> <p><i>White rectangle locates the area of microscope observations.</i></p>	<p><b>Optical Microscope</b></p> <p><b>SEM</b></p> <p><b>Desktop tomography</b></p> <p><b>Phase-contrast tomography on Synchrotron</b></p>	<p>No visible deterioration except scratches (provenance unknown), no macro-cracks, no yellowing or milky aspect.</p> <p>The scratches on the Viacryl® expose the glass paint to environment. Did the scratches damage the grisaille?</p> <p><i>White rectangle locates the area of SEM observations.</i></p>

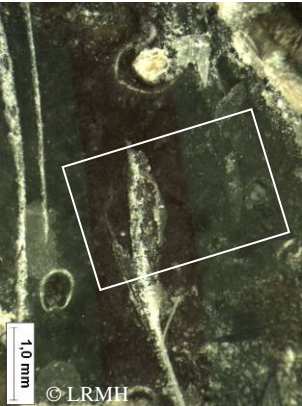
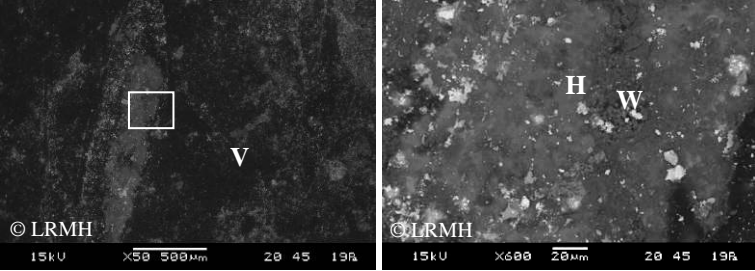
<p>© LRMH 1,0 mm</p> <p>© LRMH 15kV x50 500µm 20 45 19R</p> <p>© LRMH 15kV x600 20µm 20 45 19R</p> <p>Details of a scratch: healthy (H) and weathered (W) glass paint appear under damaged Viacryl® (V).</p> <p>Slice of the piece of glass (dense grey) with Viacryl® film (darker layer) coated on the grisaille (arrows):</p>

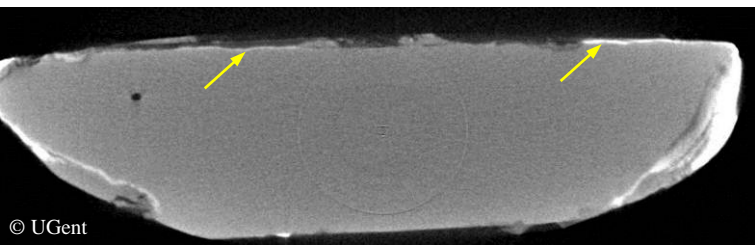
<p>© UGent</p> <p>The adherence of the film seems to be still good, either on glass, or on grisaille, or on putty.</p> <p><i>Not foreseen in this case</i></p>

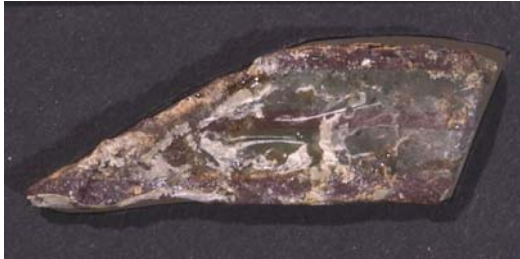
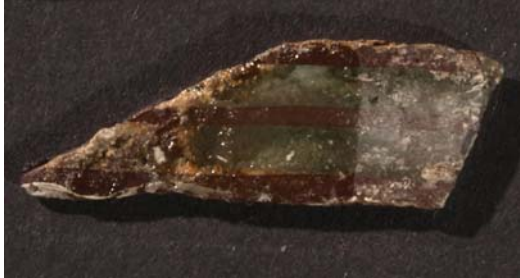
<p style="text-align: right;">After re-treatment</p> <p>As on the sample v2, desktop tomography did not provide information on the re-treatment. A doping of Paraloid® was tried in order to see it on the sample, but then it is hard to distinguish the polymer from the grisaille.</p>

<b>Microbiology</b>	<b>Molecular biology ATP measurements</b>	<i>Not foreseen in this case, see sample "microbiology tests" at the end of this data sheet.</i>
<b>Reversibility</b>	<b>Test studies Elimination</b>	<p>A first application of 2 hours was made with a poultice of Methylketone (MEK), but nothing changed. The cleaning was finally made with ethanol poultices, with several applications during 6hours.</p> <p>Then, the piece has been coated with Paraloid® B72 (doping : B72 5% : EE/Toluol 95%, 20% Sartomer 349).</p>

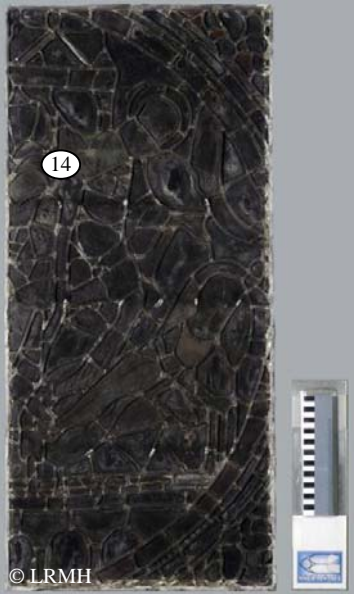
</div>	<p><b>Molecular biology ATP measurements</b>  (Microscopical analysis, metabolic activity and taxonomical description of microorganism)</p>	<p>Treatment with VIACRYL® (coarse application, in storage):</p> <ul style="list-style-type: none"> <li>- slight accumulation of dust and dirt, no visible fungal infestation</li> <li>- low metabolic activity (ATP 159 RLU/25 cm<sup>2</sup>)</li> <li>- isolated microorganisms: none</li> </ul> <p>Conclusion: No problem, no contamination</p>
