CONSTGLASS

Table of results

1- Pilot Object

Pilot object:	The <i>Typological Passion</i> , CHARTRES Bay 37, panel 44	
Picture

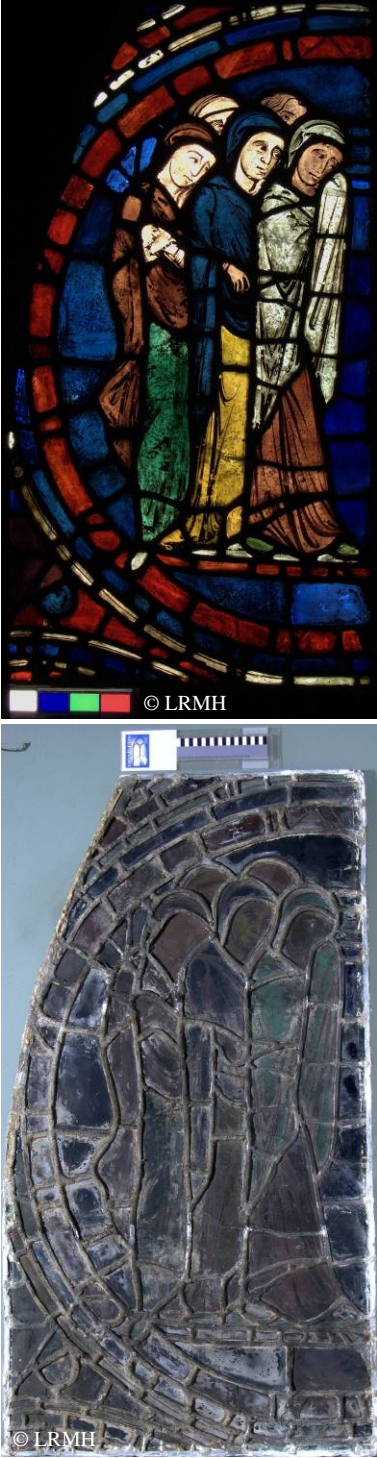
<p>Identification of the panel:</p> <p>Bay: 37 Panel: 44 Internal face, transmitted light Internal face, reflected light</p> <p>Treatment:</p> <ul style="list-style-type: none">- 1988, by Alliou studio.- Product: polyurethane resin (80% Viacryl® SM564 + 20% Desmodur® N75).- Application: with a soft brush after cleaning.

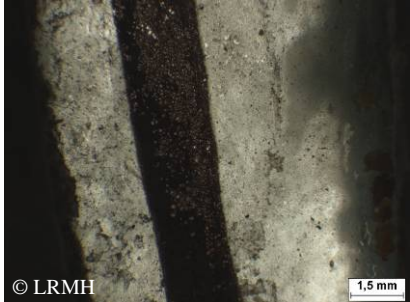
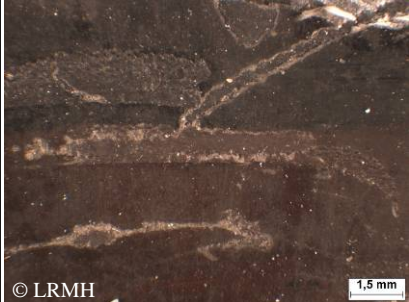
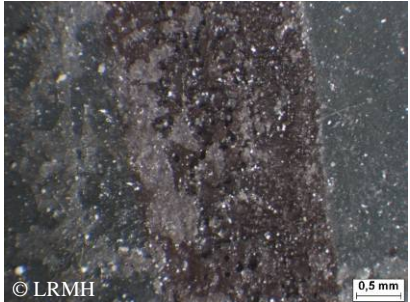
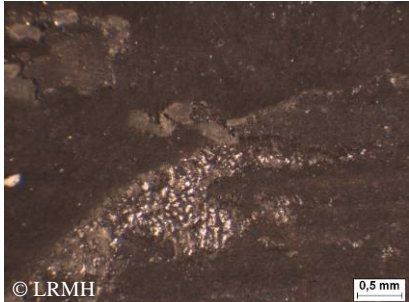
Questions	Techniques	Answers	
<p>Morphology</p> <ul style="list-style-type: none"> - <i>What is the morphology of the coating under paint?</i> - <i>How is the bonding between coating and glass, and coating and paint?</i> 	<p>Optical Microscope</p>	<p>No visible deterioration except scratches (provenance unknown) on some pieces (v4 for example), no macro-cracks, no yellowing or milky aspect.</p> <p>The glass paint on white glass (v1) was very porous because of a firing at a too high temperature.</p>

<p>© LRMH 0,5 mm</p>
		<p>Sample v1, detail of the glass paint, transmitted light.</p>	<p>Sample v4, detail of the surface of the piece with scratches on Viacryl® coating, the glass paint is bore, reflected light.</p>
		<p>Sample v1, detail of the surface of the piece with rests of Viacryl®: no more adherence with the support.</p>	<p>Sample v4, detail of glass paint with Viacryl®: milky aspect when loss of adherence, lumpy and brilliant aspect.</p>

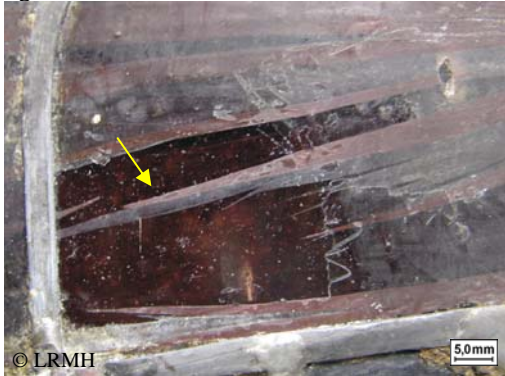
<p>© LRMH</p> <p>The arrow show the cleaned area: ethanol gel is effective, less dangerous than N-methyl-2-pyrrolidone for the grisaille and the human.</p>
<p>Re-treatability - Necessity? Which product? - Compatibility? Durability?</p>	<p>Test studies Re-treatability</p>	<p>No need to re-treat grisaille on this case. <i>See tests performed on bay 37, panel 16.</i></p>

<p>Reversibility - Removal without damage? - Method, solvent?</p>	<p>Test studies Elimination</p>	<p>Here, only ethanol gel (with Klucel G) was used to remove the polymer on a part of sample v4: 3 applications of 1 hour, rinsing with a cotton swab and ethanol, scouring.</p>

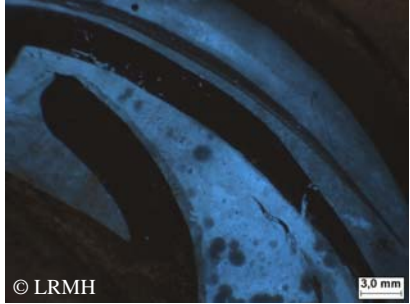
<p>Optical Microscope</p>	<p>Difficult to see Viacryl®: only excess on the edges of paint are visible with microscope. They have a lumpy and sometimes a brilliant aspect, but no macro-cracks, no yellowing or milky aspect.</p>

<p>© LRMH</p> <p><i>Sample v2, detail of paint and wash drawing, transmitted light.</i></p> <p>© LRMH</p> <p><i>Sample v3, detail of paint and wash drawing, transmitted light.</i></p>

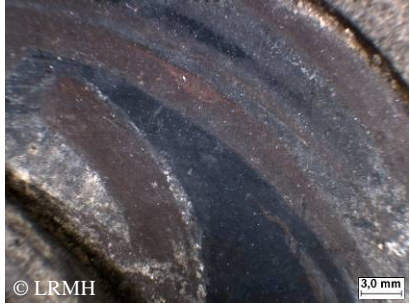
<p>© LRMH</p> <p><i>Sample v2, same view, reflected light.</i> White corrosion products seems to be located on the wash drawing.</p> <p>© LRMH</p> <p><i>Sample v3, same view, reflected light.</i> Same phenomenon as sample v2, but also on thin paint.</p> <p>The white corrosion products seem to be between glass and paint. They emerge only on thin layers and wash drawing. A higher magnification is needed to see their impact on Viacryl®.</p>

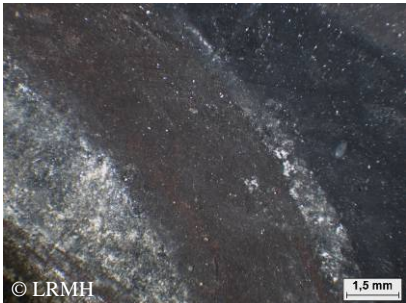
<p>© LRMH 1,5 mm © LRMH 1,5 mm</p> <p><i>Sample v2, detail of the interface paint/wash drawing : Viacryl® is on the surface of corrosion products.</i></p> <p><i>Sample v3, detail of the interface paint/wash drawing: Viacryl® is in excess on the whole surface.</i></p> <p>Viacryl® is on the surface and seems not to have changed. It's possible that corrosion products are prior to the application of the polymer.</p>
	SEM	<p><i>Not foreseen in this case</i></p>
	Desktop tomography	
	Phase-contrast tomography on Synchrotron	
Chemical Composition	SEM/EDX	
Organic component composition	FTIR	
	RAMAN	
Microbiology	Molecular biology ATP measurements	<p><i>Not foreseen in this case, see sample "microbiology tests" at the end of this data sheet.</i></p>
Reversibility	Test studies Elimination	<p><i>Not foreseen in this case, see sample v4</i></p>
Re-treatability	Test studies Re-treatability

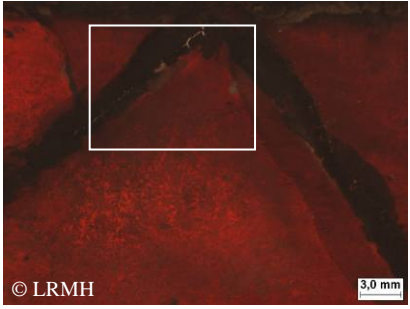
<p>© LRMH 3,0 mm</p> <p>Sample v5, detail of the silicon bonding with cold paint on , transmitted light. White rectangle locates the view below.</p> </div> <div style="text-align: center;">

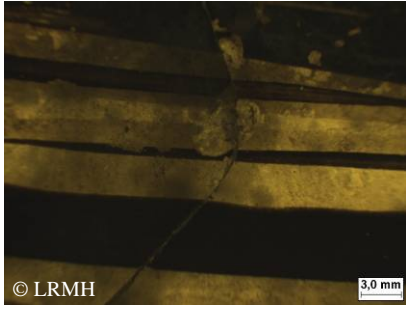
<p>© LRMH 3,0 mm</p> <p>Sample v6, detail of the silicon bonding without excess or cold paint, transmitted light.</p> </div> </div> <div style="display: flex; justify-content: space-around; margin-top: 10px;"> <div style="text-align: center;">

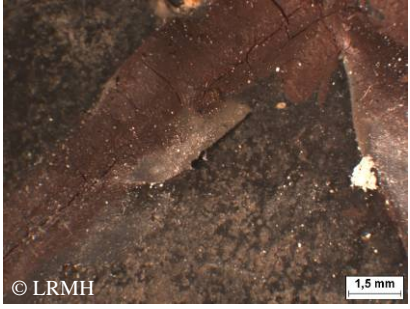
<p>© LRMH 1,5 mm</p> <p>Sample v5, detail, reflected light. Loss of adherence is not serious. Cold paint is cracked because of silicon flexibility.</p> </div> <div style="text-align: center;">

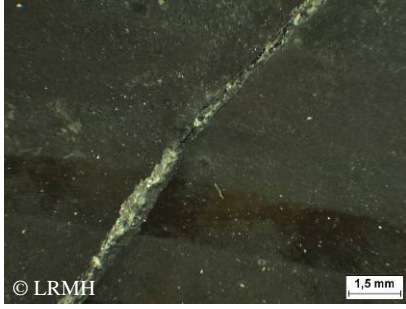
<p>© LRMH 1,5 mm</p> <p>Sample v6, detail, reflected light. White corrosion products are between edges of glass, where there is no more silicon.</p> </div> </div> <p>The adherence of the polymer with edges of the glass seems to be good, as well as mechanical behaviour. But an unstopping is harmful for most of the bondings.</p>

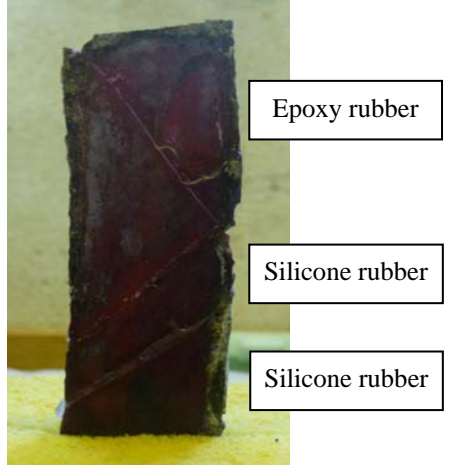
<p>Re-treatability - Necessity? Which product? - Compatibility? Durability?</p>	<p>Test studies Re-treatability</p>	<p>Two products were tested: a new transparent silicone without acetic acid (Silirub N05 neutral, Soudal) and an epoxy rubber (Araldite® 2020, ciba).</p> <p>Both of them were satisfactory during application and have a good mechanical behaviour when dried.</p>

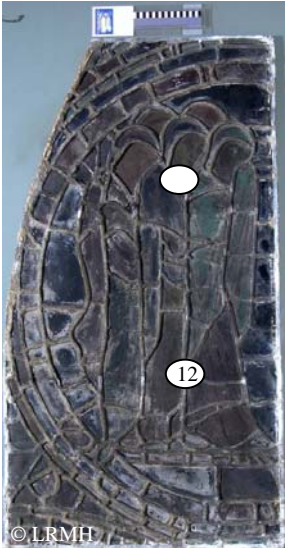
<p>Molecular biology ATP measurements (Microscopical analysis, metabolic activity and taxonomical description of microorganism)</p>	<p>Treatment with VIACRYL (coarse application, in storage, 2 samples):</p> <ul style="list-style-type: none"> - slight accumulation of dust and dirt, no visible fungal infestation - low metabolic activity (ATP 261 RLU/25 cm²) - isolated microorganisms: <i>Chaetonium globosum</i>, (fungus; low contamination) and one bacterium (not identified; low infestation) <p>Done on 2samples</p> <p>One sample nothing and one other is full of <i>Chaetonium globosum</i> (attracted by cellulose, may be due to the cleaning during last restoration)! So prudence for interpretation! No idea of impact on the glass.</p> <p>No more samples, because of the fragility of the grisaille.</p>
