CONSTGLASS

Table of results

The Death and Assumption of the Virgin, CHARTRES
Bay 42, panel 20

Sample reference: *CHA_b42p20_I_v4: white glass with Viacryl® consolidation on internal surface, silicone bonding and back plating*

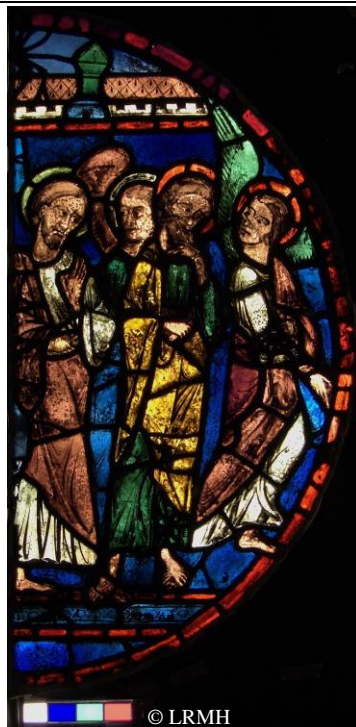
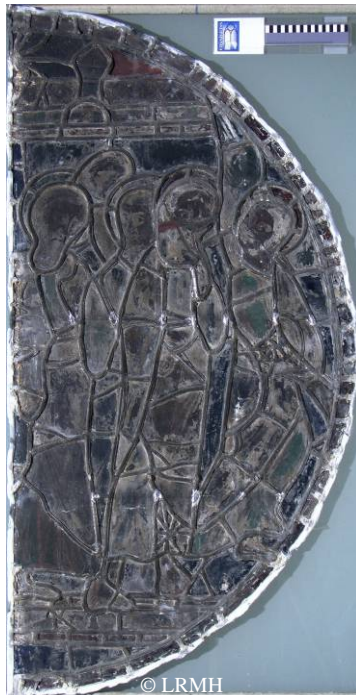
Internal face, transmitted light

Internal face, reflected light

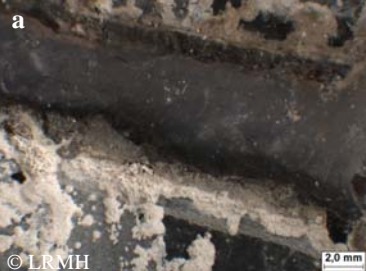
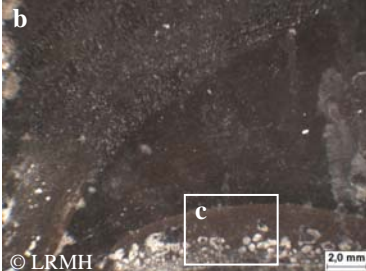
<p><i>a - detail of the silicone bonding, b - detail of consolidated grisaille external surface. No visible deterioration: it is still smooth, has a good adherence with the edges of glass.</i></p>

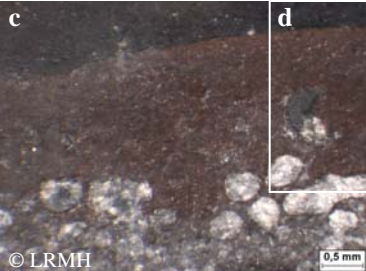
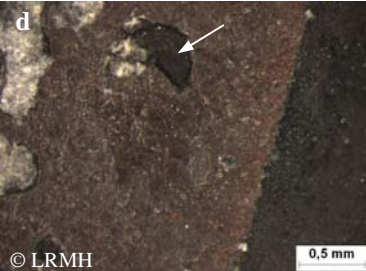
<p><i>c - detail of the grisaille before and after cleaning with a cotton saturated of water. The Viacryl® consolidant is visible on the cleaned area (brilliant aspect).</i></p> <p><i>d - detail of the grisaille after cleaning. Viacryl® seems to be still effective on the paint. Was the gap (arrow) formed before or after Viacryl® application?</i></p>
	<p>SEM</p>

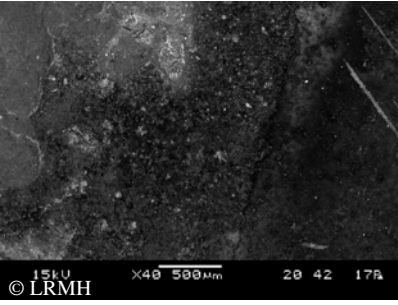
<p>The SEM confirms the microscope observations (see optical microscope photo d):</p> <ul style="list-style-type: none"> - there is organic compound (normally, Viacryl® resin), - there is no macro-cracks, - Viacryl® polymer seems to be mixed to grisaille, - deposits are in the gaps of paint (on/under Viacryl®?)

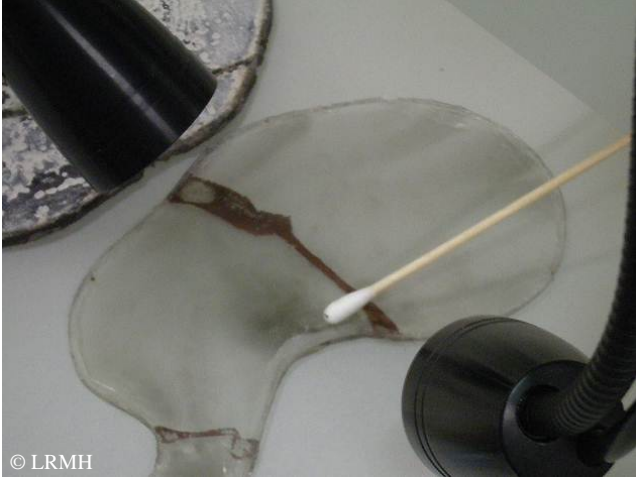
<p>© LRMH</p> Dust and soot are observed on the internal side of the recent glass, due to a non-hermetic bonding. But it does not seem to be a cause of microbial contamination. The results on silicone bonding and back plating are the following: <ul style="list-style-type: none"> • slight accumulation of dust and dirt: no visible fungal infestation; • metabolic activity: not undertaken in this case; • isolated microorganisms: none.
Reversibility	Test studies Elimination	Mechanical reversibility of the silicone rubber between back plating and ancient glass is easy: after opening the system with high precautions (with a scalpel), tearing off the joint and scouring with a rubber. Concerning glass paint, nothing was attempted regarding to its good state of conservation. <i>See tests performed on bay 37.</i>

Re-treatability	Test studies Re-treatability	Two products were tested to re-treat edge bondings: a new transparent silicone without acetic acid (Silirub N05 neutral, Soudal) and an epoxy rubber (Araldite® 2020, Ciba). Both of them were satisfactory during application and have a good mechanical behaviour when dried. No need to re-treat grisaille on this case. <i>See tests performed on bay 37, panel 16.</i>
