CONSTGLASS

Table of results

The death and assumption of the Virgin, CHARTRES
Bay 42, panel 21

Sample reference: *CHA_b42p21_I_v1: yellow glass with Viacryl® consolidation on internal surface*

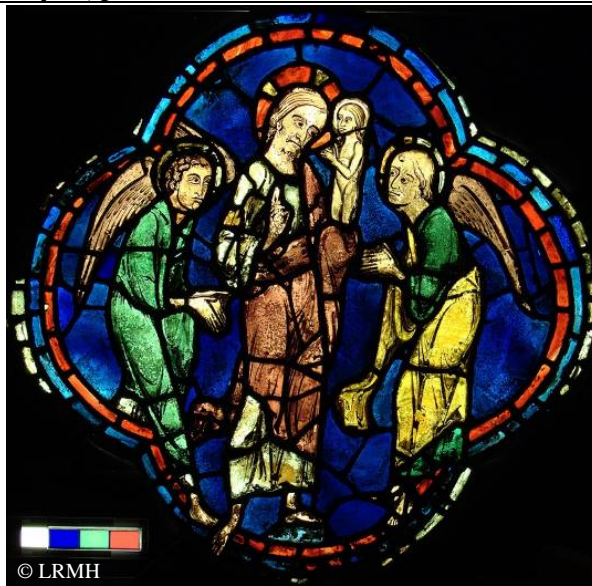
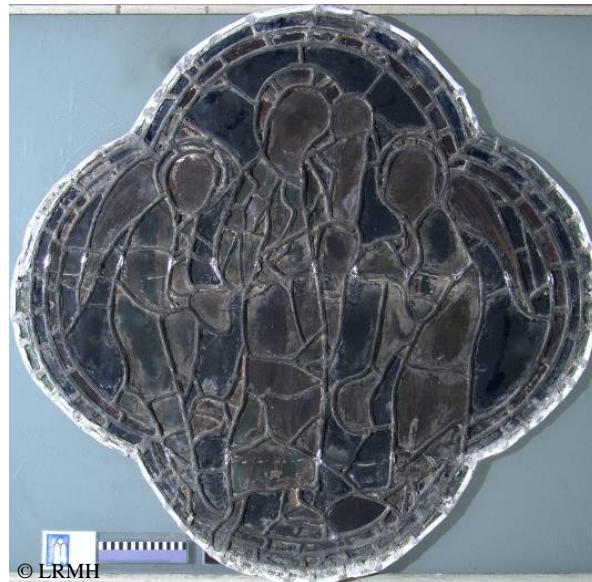
Bay: 42
Panel: 21
Internal face, transmitted light
Internal face, reflected light

Conclusion: the consolidation is still effective on most of the paints of the panel. There is not much corrosion products, but a lot of putty which was not removed during last restoration. The corrosion of the latter is starting or resuming on some isolated areas. On some pieces, the healthy grisaille is taken off by a thin layer of deteriorated glass. The consolidation does not avoid this phenomenon.

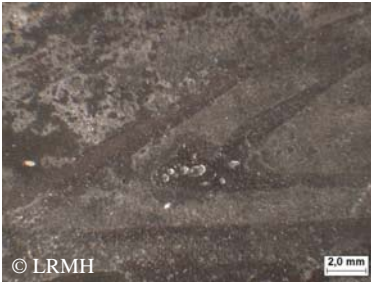
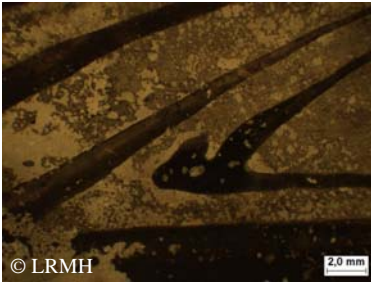
<p>© LRMH</p> <p>© LRMH</p> <p><i>Detail of internal face, reflected and transmitted light. It is covered by dust and corrosion products, which makes difficult to observe Viacryl® consolidant. On this area, the gaps of grisaille are due to bubbles, probably caused by too much baking. But the rest of the paint seems to be safe.</i></p>

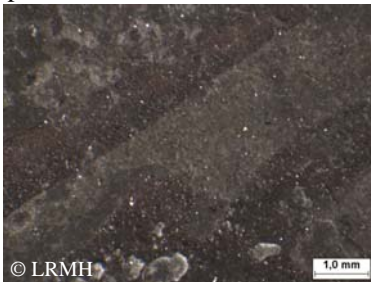
<p>© LRMH</p> <p><i>Detail of glass paint, reflected light.</i></p>	
	<p>SEM</p>	<p><i>Not foreseen in this case: sample hasn't been unstopped.</i></p>
	<p>Desktop tomography</p>	<p><i>Not foreseen in this case: samples too large for tomography system.</i></p>

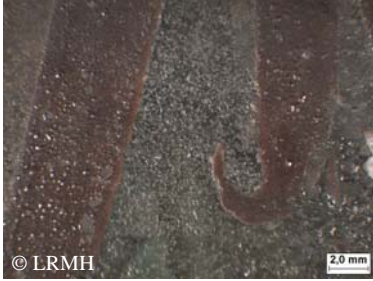
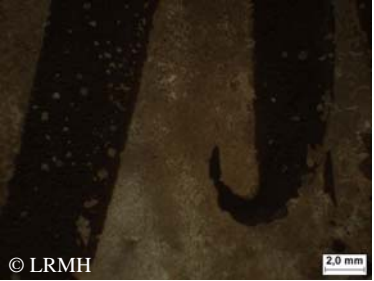
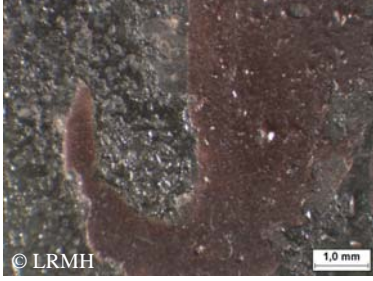
<p>© LRMH</p> <p>© LRMH</p> <p>© LRMH</p>	<p><i>Detail of internal face, reflected and transmitted light. Same phenomenon as sample v4 and most of the pieces of this panel: the superficial layer of glass is gone, taking with it the grisaille.</i></p> <p><i>Detail of glass paint, reflected light. It is covered by dust and corrosion products, which makes difficult to observe Viacryl® consolidant. On this area, the gaps of grisaille are due to bubbles, probably caused by too much baking. But the rest of the paint seems to be safe.</i></p>
	<p>SEM</p>	<p><i>Not foreseen in this case: sample hasn't been unstopped.</i></p>

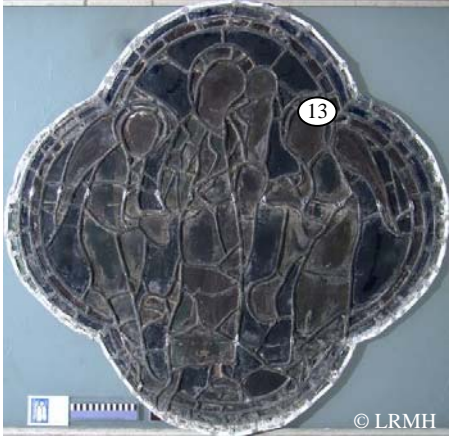
<p>Molecular biology ATP measurements (Microscopical analysis, metabolic activity and taxonomical description of microorganism)</p>	<p>Treatment with VIACRYL® (fine application, in storage):</p> <ul style="list-style-type: none"> - slight accumulation of dust and dirt, no visible fungal infestation; - low metabolic activity (ATP 143 RLU/25 cm²); - isolated microorganisms: none. <p>Only one sample has been made, as a precaution for the grisaille.</p>
