CONSTGLASS

1-Pilot object

Pilot object: Cologne Cathedral,
N VI, choir clerestory, "Cycle of Kings" (ca. 1300)

Panel: 4bl
external face

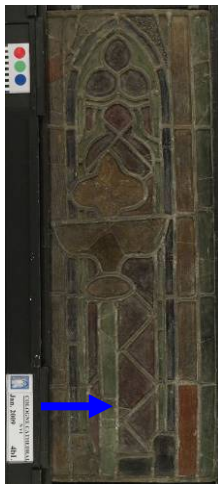
external face

<p data-bbox="100 427 209 456">Remarks</p>	<p data-bbox="767 427 1497 611">The external surface of the panel is completely coated with the ORMOCER[®] protective system. The coating is in a good condition. Here and there bubbles are visible and several parts of the coating (thick application) have a milky aspect. The putty around the glass pieces was coated with ORMOCER[®], too. From the conservator's point of view there is no need to remove the coating.</p>

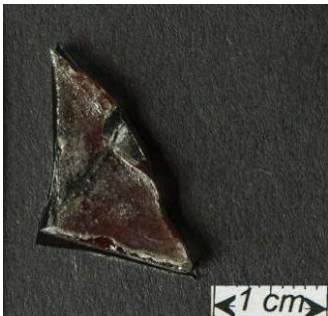
<p>Col_ORMOCER_separated_1</p>	<p>Optical Microscope (DBV)</p>	<p>Visibly the surface of the ORMOCER[®]-coating is intact, but some areas have a milky aspect (insufficient adhesion between the coating and the glass underneath? Micro-cracks in the ORMOCER[®]-layer? Progress of corrosion?).</p>
<p>Typical phenomenon of the ORMOCER[®] coating (bubbles), exemplified by another segment of the treated panel</p>

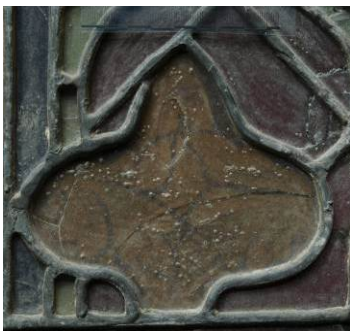
<p>external face (transmitted and reflected light)</p> <p>Partially the ORMOCER[®] coating shows bubbles.</p>

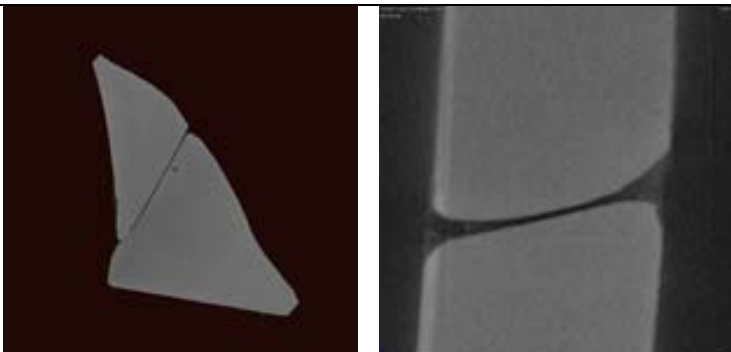
<p>ORMOCER[®] coated sample (treatment 1988): 2D slice through the glass sample. The crack is clearly visible on the CT data, due to the high attenuation of the glass and low attenuation of the crack and the glue.</p>

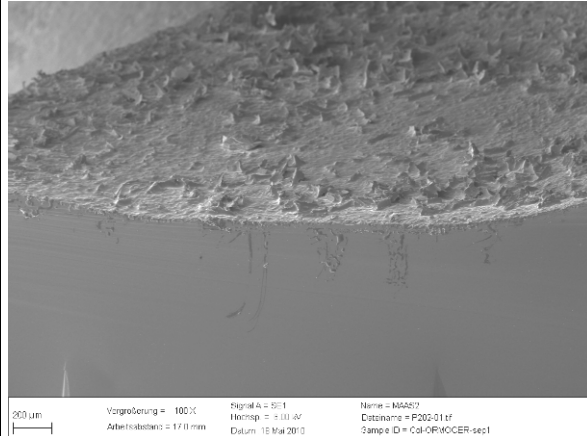
SEM picture of re-treated sample, broken via backside. Perspective view to surface and bulk material (below). On the top of the sample the glass flakes, which were original included in the coating material are visible. Obviously, not all flakes were removed with the cotton swabs.

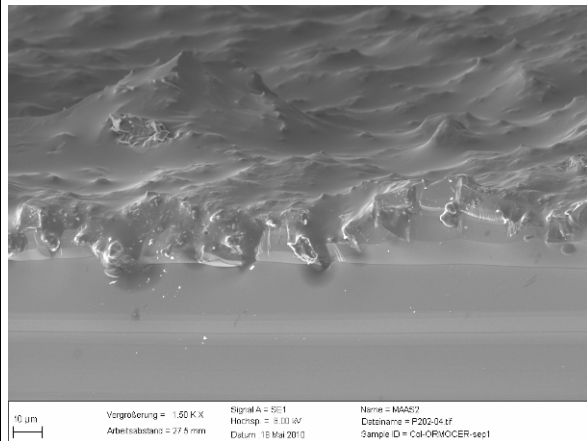
SEM-picture: The Glass flakes were enclosed by the Paraloid[®], which was applied during the re-treatment.

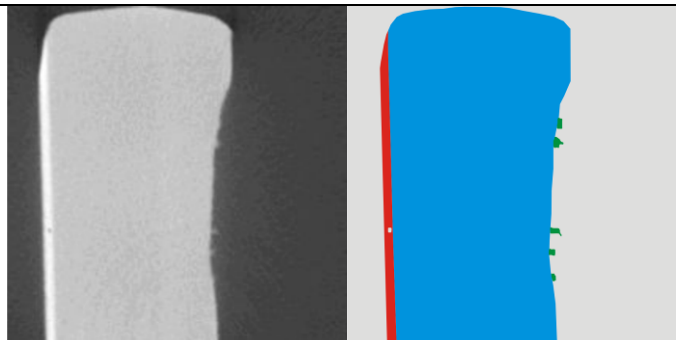
After the removal of ORMOCER[®] and afterwards re-treatment with Paraloid[®] B72. For better contrast the Paraloid[®] was doped with Sartomer[®] and Iodine.

Green: traces of Paraloid[®] or rest of glass flakes, formerly embedded in the ORMOCER[®] coating?

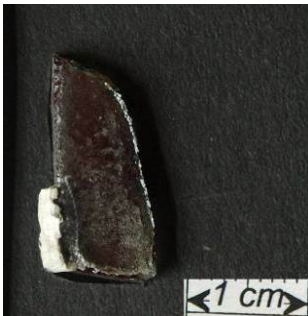
<p>Col_ORMOCER_separated_2</p>	<p>Optical Microscope (ISC)</p>

<p>Reflecting light: coating looses adhesion and flakes off only at the borders of the sample, whitish glass corrosion crystals underneath the coating do not affect the coating system.</p>

<p>Transmitting light: same detail as above, remnants of glass corrosion products (dark structures) underneath the coating, no micro fissures in the coating.</p>

<p>Reflecting light: Areas with a thick Paraloid[®] top coating (upper border of the sample) appear more transparent than parts of thin Paraloid[®] application (milky appearance).</p> <p>Visibly the surface of the ORMOCER[®]-coating is intact. The adhesion between the coating system and the glass underneath is sufficient. Flaking of at the borders is probably due to mechanical stress during taking the samples. There are no micro-cracks in the ORMOCER[®]-layer.</p> <p>The milky aspect appears in areas of very thin Paraloid[®] top coating and due to the corrosion of glass flakes (which are not well embedded) and / or a rough surface of the ORMOCER[®] layer. Moreover, despite the cleaning process before treatment remnants of glass corrosion products can be detected underneath. They also have an influence on the appearance of the coating system. There are no signs for the development of new corrosion crystals (detachment of the coating, micro fissures etc.).</p>

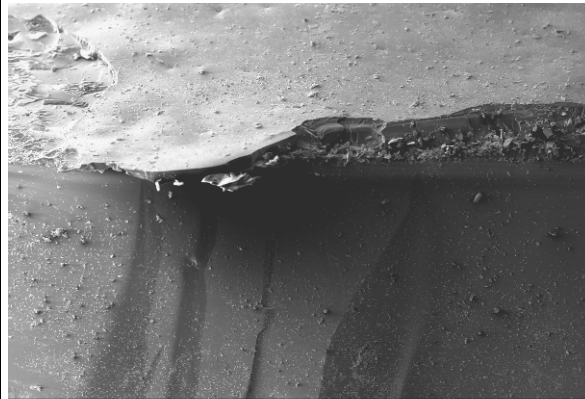
SEM picture: The ORMOCER[®] shows, even after the exposure a good adhesion to glass. No fissures between glass and ORMOCER[®] are detectable. The embedded glass flakes are almost covered by the ORMOCER[®] and Paraloid[®].

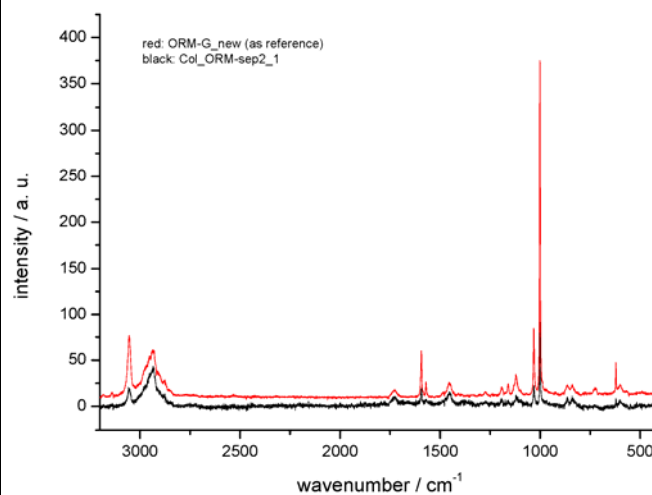
The spectra of the weathered Col_ORMOCERe_separated_2 (black spectra below) layer is comparable with a fresh applied ORMOCER[®] (upper red spectra). No chemical changes of the ORMOCER[®] during over 20 years of exposure are observable.

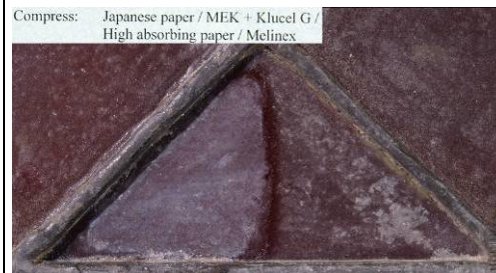
NVI 4br, reflected light

Additionally, remains of the embedded glass flakes had to be removed with MEK-soaked cotton swabs; to remove every flake was impossible; there are still remains on the surface. Close to the framing lead profiles there are remains of ORMOCER®, too.
