CONSTGLASS

Table of results
Klausen

Klausen, Parish Church

I, choir, axial window, "Crucifixion and Flight to Egypt" (1878)

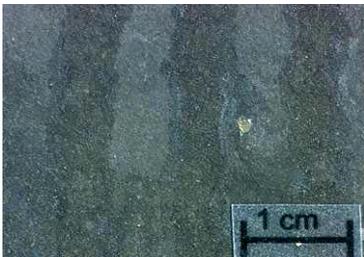
<p>The borderline of consolidated and not consolidated parts is visible due to the darkening of consolidated areas. Flaky paint seems to be fixed well.</p>	<p>Optical Microscope (DBV, ISC)</p>	<p>The contour lines were coated with ORMOCER[®]. The upper half of the test segment was treated two times; the lower part got a single treatment. The treatment of the contours is visible (darker appearance). During the application, the ORMOCER[®] sunk sufficiently into the contours and the unfired paint layer. The today's condition of the ORMOCER[®]-layer seems to be stable.</p> <p>Additional pictures of a comparable segment, illustrating the condition of the paint-layer; the yellow glass segment was treated with ORMOCER[®], the green one with Paraloid[®] B72:</p>

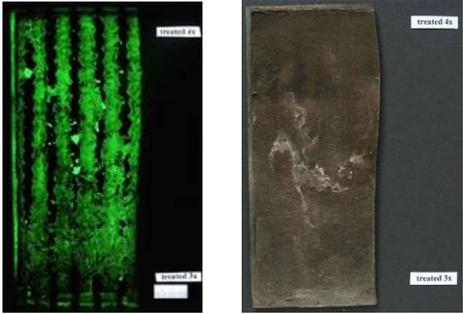
<p>internal face</p> <p>These picture shows the complete sample, that was afterwards divided in 3 single pieces</p>	<p>Optical Microscope (DBV, ISC)</p>	<p>The fired paint contours were coated with SZA. The upper half of the test segment was treated 4 x, the lower was treated 3 x.</p> <p>The SZA treatment of the contours is not visible. During the application SZA sunk well into the contours. But due to its highly fluid character, the SZA inevitably spread out onto the surrounding area, including the overlaying film of unfired pigmented oil-lacquer that was applied in restoration around 1900.</p> <p>The today's condition of the SZA seems to be stable. The SZA can hardly be identified by light microscopy. There are no alteration phenomena (e.g. whitening effect) of the consolidant detectable at the sample. Flaky paint seems to be stable and does not flake off if stressed mechanically softly.</p> <p>Additional pictures of comparable segment, illustrating the condition of the paint-layer treated with SZA</p>

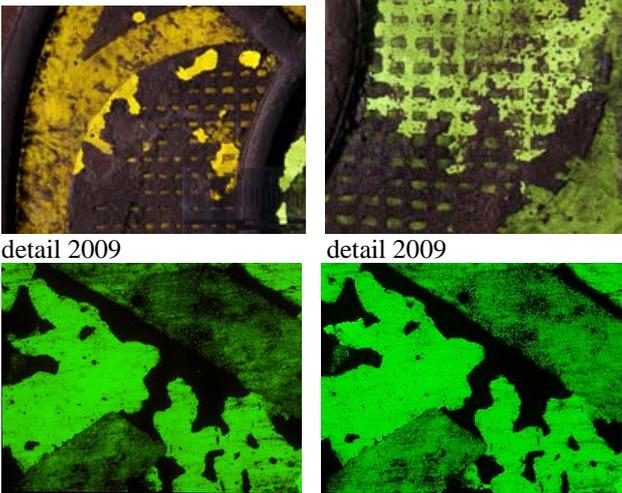
<p>detail 2009 detail 2009</p> <p>detail 1991.... in comparison to 2009</p>

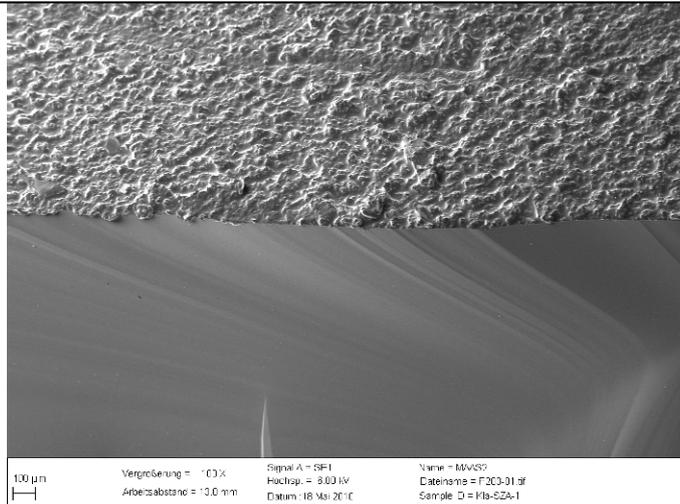
KLA_SZA_1_separated_1 (after re-treatment with Paraloid® B72).

Broken glass fragment. The roughness of the thin paint layer is very good observable in the upper part of the picture. In the lower part the glass bulk material is visible. The picture was taken in a perspective view, see scheme below.

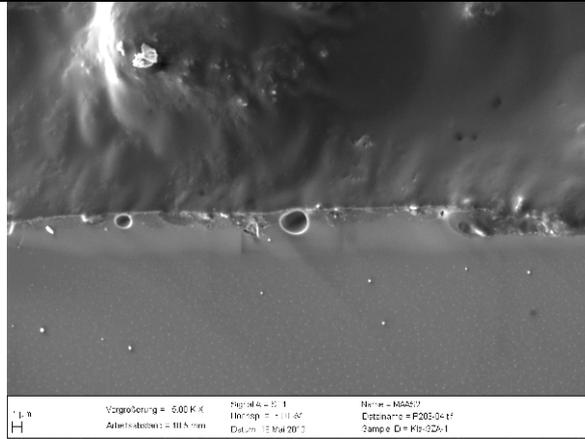
Between coating and glass is a thin layer visible; this might be the paintlayer.

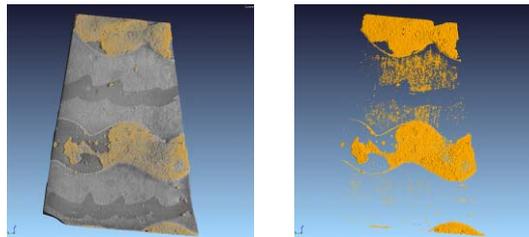
KLA_SZA_1_separated_1

3D visualization of the glass sample, with dense layer coloured in yellow.

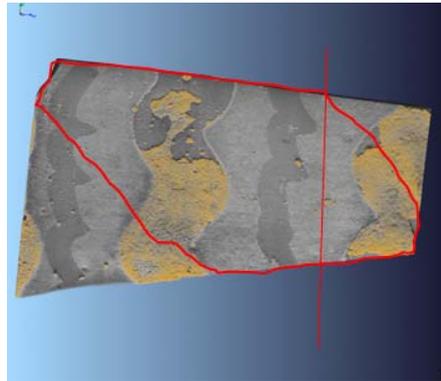
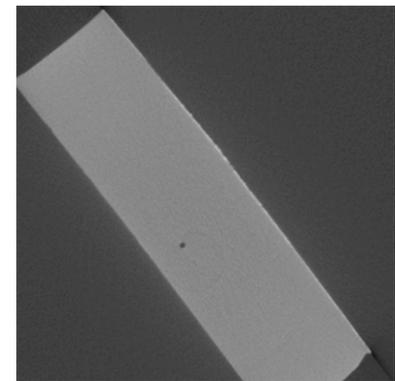
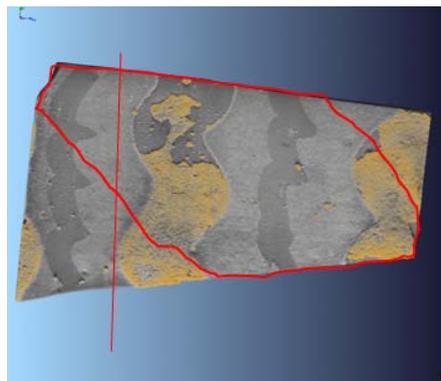
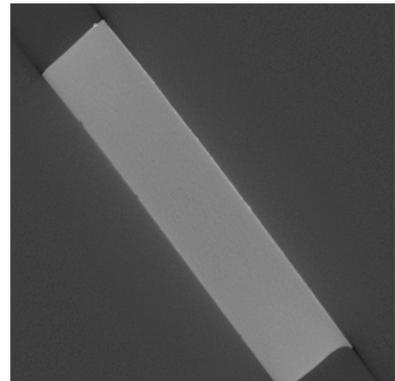
After re-treatment, no structural changes could be seen on the pictures. We could not see the removal of SZA or the new application of Paraloid® B72 even when it is doped. This is because the layers are too thin.

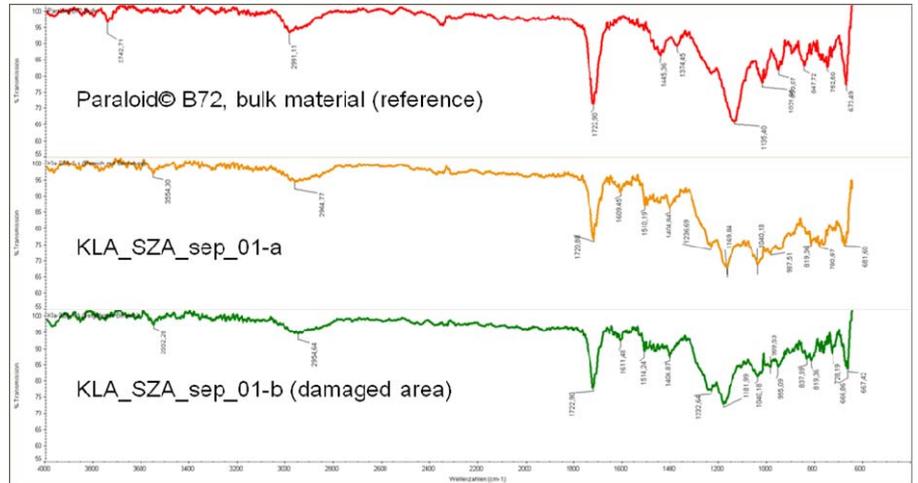
The two measured spectra are similar to Paraloid® B72, measured as a reference on bulk material. Also the damage area was coated with Paraloid® B72. The underneath paint layer has no influence on measuring (organic) spectra with ATR-FTIR, compare Kla_SZA_separated_1-a and Kla_SZA_separated_1-b.

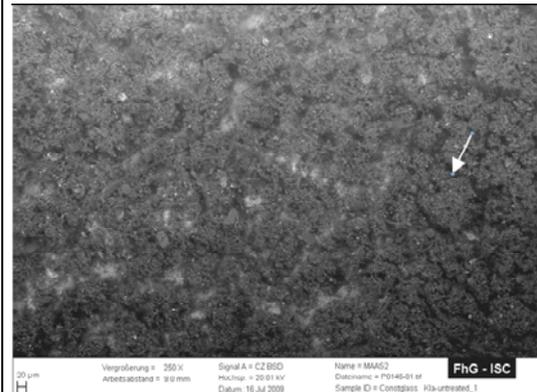
Loose painting with irregular structure and partially islanding.

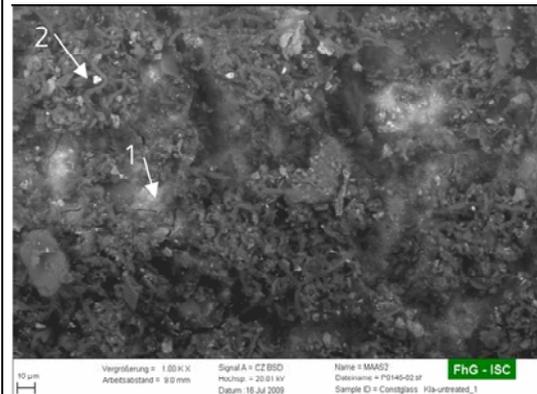
Painting looks partial very thin. Crack structure of the original glass is visible (1). Long and fibrous structures could be interpreted as hint for microbiology (2), but this was not verified by subsequent microbial investigation.
