**CONSTGLASS**

Table of results

The *Crowning Virgin and the 12 apostles*, LE MANS  
Bay XVI, panel 10

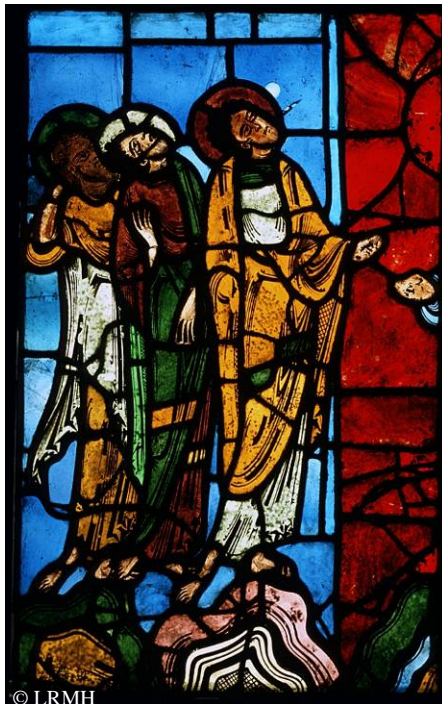
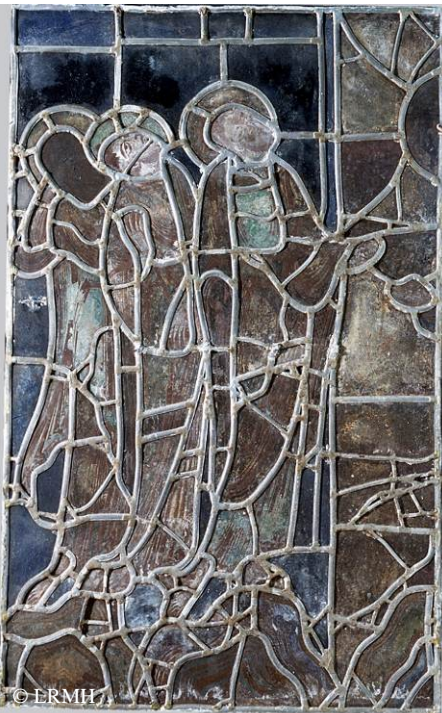
Internal face, transmitted light

Internal face, reflected light

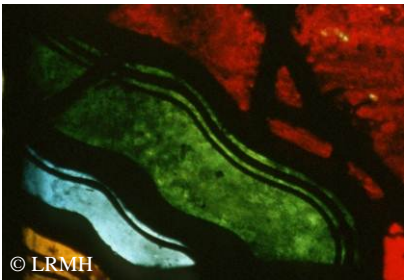
<p>© LRMH <i>Transmitted light, internal surface</i></p>

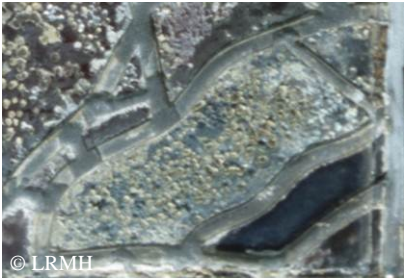
<p>© LRMH <i>Reflected light, external surface</i></p> </div>	<p><b>Optical Microscope</b></p>	<div style="display: flex; justify-content: space-around;">

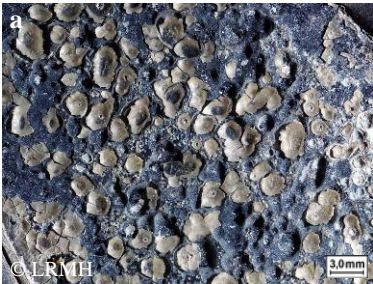
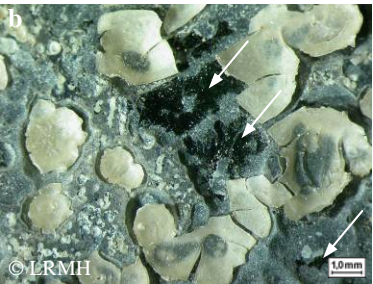
</div> <p>© LRMH      © LRMH</p> <p><i>a - Viacryl flakes in glass craters.      b - Detail of the glass surface.</i></p> <p>On most of the pieces, Viacryl® has been washed away by rain and wind. Here, a large part is still in the craters: we can see the film has been retracted when hardened; it is yellowing and has a milky aspect. In some craters, healthy glass is bared (<b>b-</b>, arrows).</p>

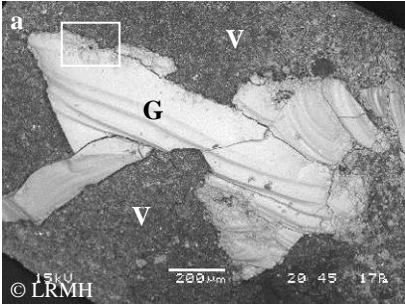
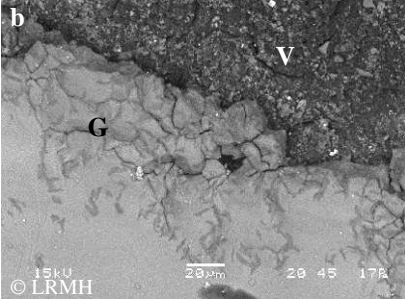
</div> <p>© LRMH      © LRMH</p> <p><i>a - internal face of the flake. The healthy glass (G) has been torn off with Viacryl® (V). There is not much corrosion products (the white rectangle locates image b-).</i></p> <p><i>b - Glass on the contact of Viacryl®</i></p> <p>A higher magnification highlights the cracks in the gel layer at the surface of the glass.</p>	<p>A flake of Viacryl® has been sampled on the external face.</p>
	<p><b>Desktop tomography</b></p>		<i>Not foreseen in this case</i>
	<p><b>Phase-contrast tomography on Synchrotron</b></p>		<i>Not foreseen in this case</i>
<p><b>Chemical Composition</b></p> <ul style="list-style-type: none"> <li>- What is the chemical composition of the alteration products?</li> </ul>	<p><b>SEM/EDX</b></p>	<p>The gel layer is a stratum of glass depleted in alkali and alkaline earth metal.</p>

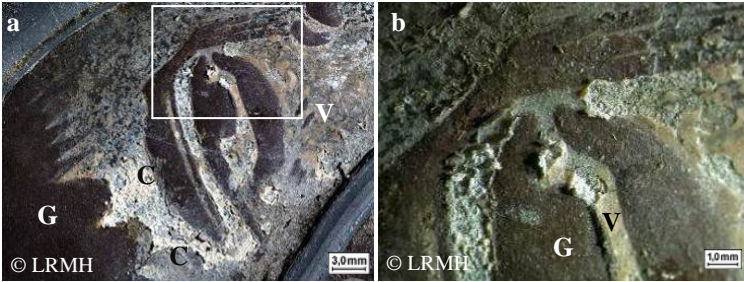
<p><b>a</b> – Viacryl® on glass and grisaille. It's flaking where corrosion has restarted. <b>b</b> - Detail of the Viacryl® delamination on glass corrosion products</p> <p>Most of the grisaille has a good shape on the glass. But on some areas, corrosion products are emerging on the glass and the paint, pushing away the Viacryl®. It is hard to say if this phenomenon takes off the grisaille from its support.</p>
	<p><b>SEM</b></p>

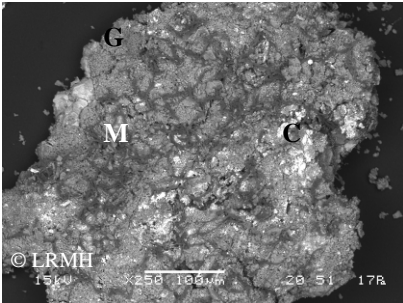
<p>Corrosion products (C) under Viacryl® have been sampled on the weathered glass (G).</p> <p><i>Internal surface of Viacryl® film: between film and glass.</i></p> <p>In addition to gypsum, some micro-organisms (M) are visible on this SEM picture. They are not active anymore, but their presence is an indication of a favourable environment for their growth.</p>

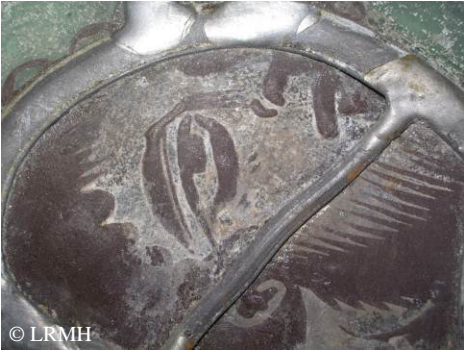
<p>Viacryl® and most of corrosion products have been cleaned, the grisaille is still in a good state of conservation.</p>
<b>Re-treatability</b>	<b>Test studies Re-treatability</b>	<p>No re-treatability was recommended. An external protective glazing was installed in 2008, by Debitus studio (Tours, 37).</p>

<b>Reversibility</b>	<b>Test studies Elimination</b>	<p>The restoration has been made in 2005 by Pivet studio (Morthemer, 86). N-methyl-2-pyrrolidone has been used to remove corrosion products and Viacryl® on glass in internal surface.</p>

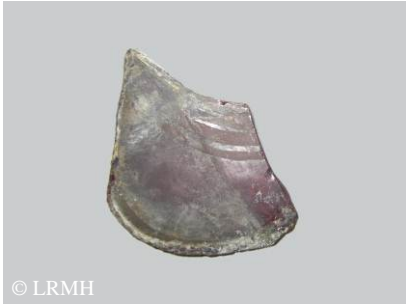
<p>© LRMH</p> <p><i>Reflected light, after cleaning on the right area</i></p>	<p><b>Optical Microscope</b></p>	<p>This piece was sampled to observe the impact of the cleaning on the grisaille which is thick and has a good adherence.</p>

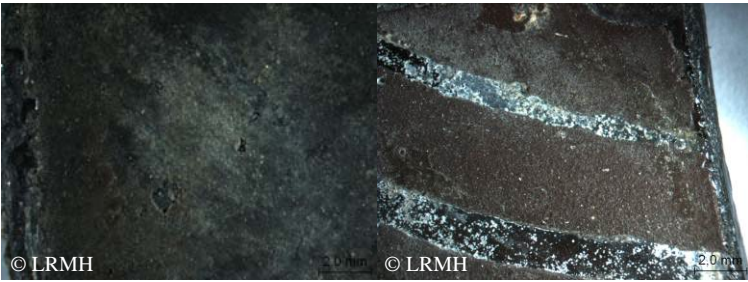
<p>© LRMH 10µm © LRMH 20µm</p> <p><i>Corrosion products with Viacryl® film (a-), and a cleaned area (b-). The cleaning permits to reveal a smooth or altered (by white pits) glass and a rough paint. It remains Viacryl® on some little areas.</i></p>
	<p><b>SEM</b></p>

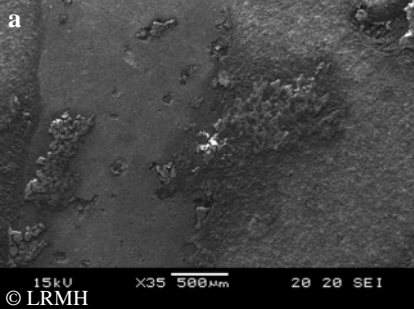
<p>a- Cleaned area of the internal surface: glass and grisaille (Secondary Electron view: information on the shape of the surface).</p>

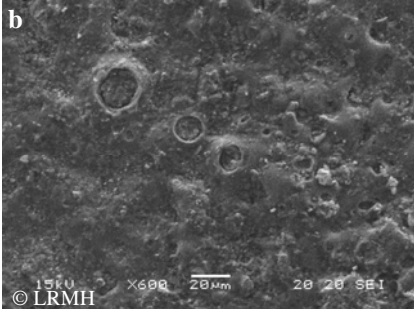
<p>b- Detail of the grisaille surface after cleaning (Secondary Electron view)</p> <p>The SEM-SE view confirms the glass is smooth, except some cracks due to its alteration. A higher magnification indicates the grisaille is spongy. It's due to bubbles which exploded when cooking. Despite its porosity, the grisaille seems not to be damaged by the cleaning. But the comparison before/after cleaning was not possible because of the Viacryl® and dust.</p>
