CONSTGLASS

Table of results

The *Crowning Virgin and the 12 apostles*, LE MANS
Bay XVI, panel 11

Sample reference: *CHA_bXVIp11_E_v5 : red glass, coated with Viacryl® on external surface*

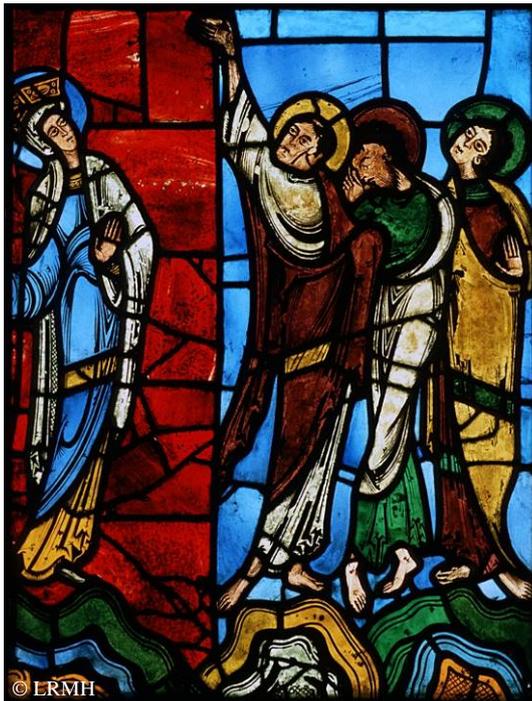
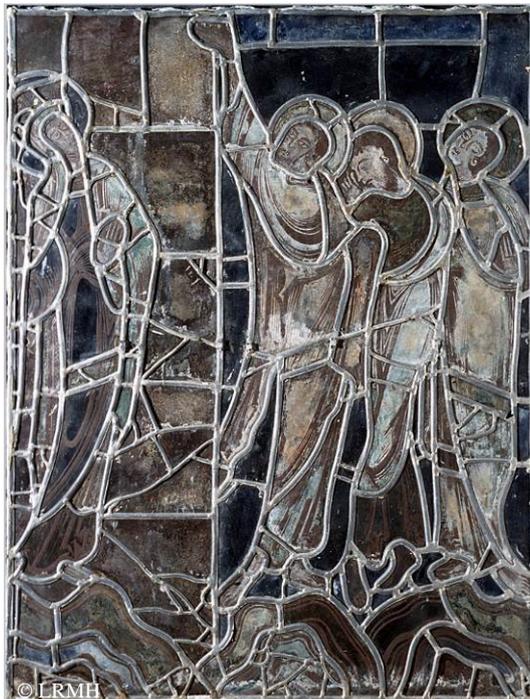
Internal face, transmitted light

Internal face, reflected light

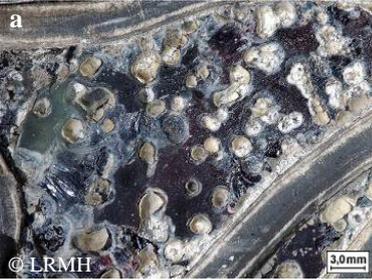
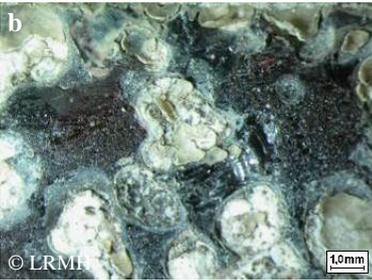
<p>© LRMH</p> </div> </div> <p><i>a – Viacryl® flakes in glass craters. b - Detail of the glass surface.</i></p> <p>On most of the pieces, Viacryl® has been washed away by rain and wind. Here, a large part is still in the craters: we can see the film has been retracted when hardened, it is yellowing and has a milky aspect. A large part of healthy glass is bared (brilliant aspect).</p>

<p>Reversibility</p>	<p>Test studies Elimination</p>	<p><i>Not foreseen in this case, see sample v3</i></p>	
<p>Re-treatability</p>	<p>Test studies Re-treatability</p>	<p>No re-treatability was recommended. An external protective glazing was installed in 2008, by Debitus studio (Tours, 37).</p>

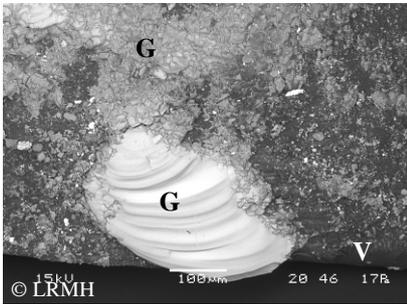
<p>© LRMH</p> </div>	<p>A flake of Viacryl® has been sampled on the external face.</p> <p><i>Internal face of the flake. The glass (G) – healthy (light grey) and gel layer (grey) – has been torn off with Viacryl® (V). There is not much corrosion products.</i></p>
	<p>Desktop tomography</p>	<p>SEM/EDX</p>	<p><i>Not foreseen in this case</i></p>
	<p>Phase-contrast tomography on Synchrotron</p>	<p>FTIR</p> <p>RAMAN</p>	<p><i>Not foreseen in this case, see panel 10</i></p>
<p>Chemical Composition</p> <ul style="list-style-type: none"> - What is the chemical composition of the alteration products? 	<p>SEM/EDX</p>	<p>The gel layer is a stratum of glass depleted in alkali and alkaline earth metal.</p>	
<p>Organic component composition</p>	<p>FTIR</p> <p>RAMAN</p>	<p><i>Not foreseen in this case, see panel 10</i></p>	
<p>Microbiology</p>	<p>Molecular biology, ATP measurements</p>	<p><i>Not foreseen in this case, see panel 6</i></p>

Conclusion: On the external face, it remains not much Viacryl®. But microscope and SEM observations show the Viacryl® takes off the gel layer and the healthy glass when the film is cleaned by rainwater. In 2005, the rests of polymer has been removed to avoid these problems.

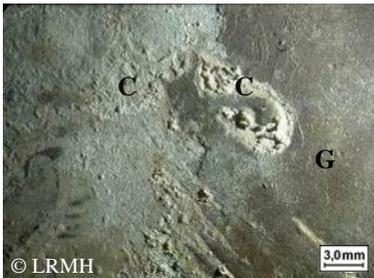
<p><i>Viacryl® on grisaille (G) and glass. It's flaking where corrosion (C) has restarted (particularly on glass).</i></p> <p>© LRMH</p>

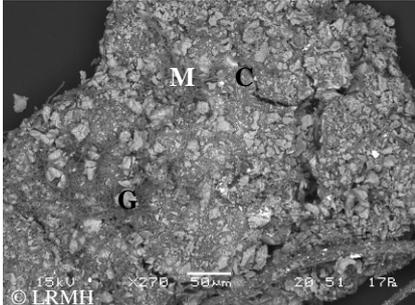
<p>© LRMH 15 kV x278 50µm 28 51 17R</p> <p><i>Corrosion products (C) under Viacryl® have been sampled on the weathered glass (G).</i></p> <p><i>Internal surface of Viacryl®-film: between film and glass.</i></p> <p>In addition to gypsum, some micro-organisms (M) are visible on this SEM picture. They are not active anymore, but their presence is an indication of a favourable environment for their growth.</p>

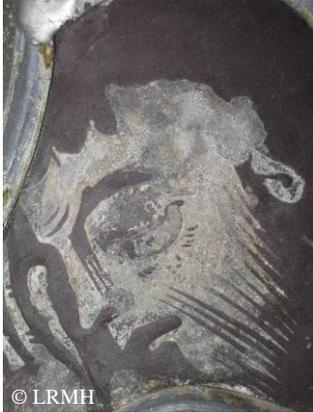
On the internal face, the consolidation is still good on most of the paints. Where corrosion products are on the glass paint, they don't seem to have an impact, because in this case they seem to come from alteration of the putty. If they were coming from the glass, it would damage the paint. The excess of Viacryl® on glass is no more effective because of alteration growing.

<p>© LRMH</p>	<p>The restoration has been made in 2005 by Pivet studio (Morthemer, 86). N-methyl-2-pyrrolidone has been used to remove corrosion products and Viacryl® on glass in internal surface.</p> <p>Viacryl® and most of corrosion products have been cleaned, the grisaille is still in a good state of conservation.</p>
Re-treatability	Test studies Re-treatability	<p>No re-treatability was recommended. An external protective glazing was installed in 2008, by Debitus studio (Tours, 37).</p>
