CONSTGLASS

The Crowning Virgin and the 12 apostles, LE MANS
Bay XVI, panel 7

Sample reference: *CHA_bXVIp7_E_v4 : red glass, coated with Viacryl® on external surface*

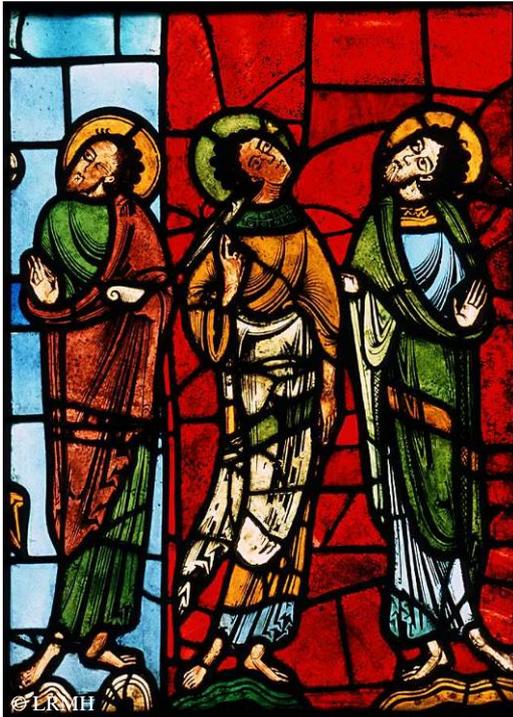
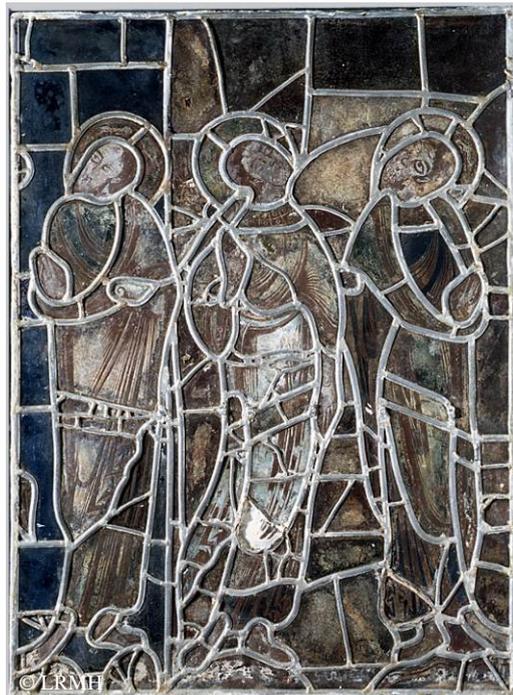
Internal face, transmitted light

Internal face, reflected light

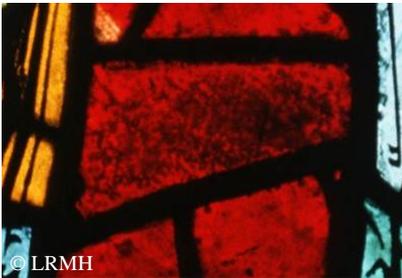
<p>© LRMH <i>Transmitted light, internal surface</i></p>

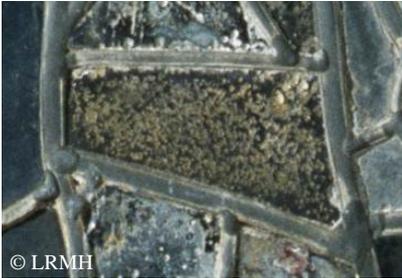
<p>© LRMH <i>Reflected light, external surface</i></p> </div>	<p>Optical Microscope</p>

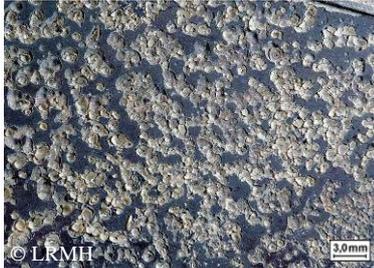
<p>© LRMH 3.0mm</p> <p>On most of the pieces, Viacryl® has been washed away by rain and wind. Here, a large part is still in the craters: we can see the film has been retracted when hardened, it is yellowing and has a milky aspect.</p> <p><i>Overview of flakes in craters.</i></p>
	<p>SEM</p>

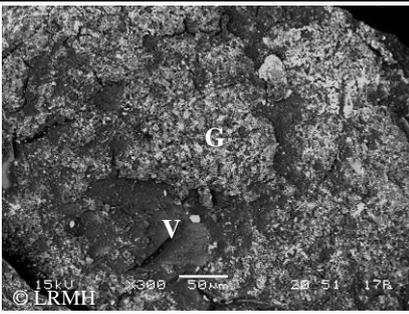
<p>© LRMH 15kV x300 50µm 20 51 17R</p> <p>A flake of Viacryl® has been sampled. The gel layer (G) has been torn off with Viacryl® (V). There is not much corrosion products.</p>
	<p>Desktop tomography</p>	<p><i>Not foreseen in this case</i></p>

Conclusion: On the external face, it remains not much protective film. SEM investigations show that Viacryl® torn off a part of the gel layer.

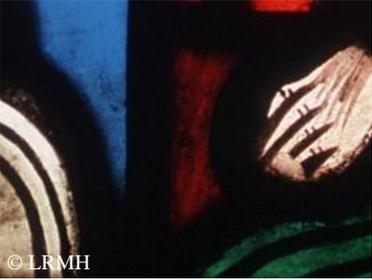
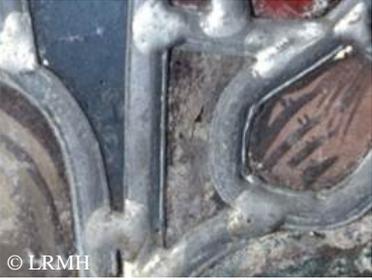
<p>© LRMH Transmitted and reflected light</p>	<p>Optical Microscope</p> <p>SEM</p> <p>Desktop tomography</p> <p>Phase-contrast tomography on Synchrotron</p>	<p><i>No optical microscope view</i></p> <p>The whole surface of the piece is covered by corrosion products under Viacryl® film.</p>

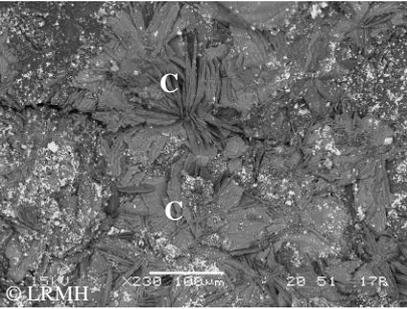
<p>Corrosion products (C) with Viacryl® (V) have been sampled on the glass (G).</p> <p><i>a - external surface of Viacryl® film.</i></p>

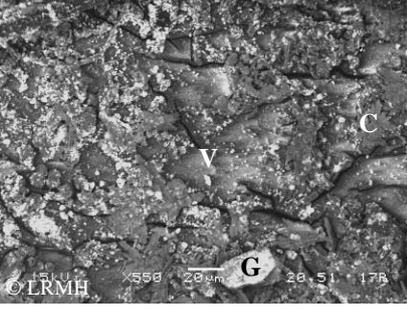
<p><i>b - internal surface of Viacryl® film : between film and glass.</i></p> <p>The neo-crystallisations of gypsum are different depending on the condition of growth. On the film, their diameter is about 150µm, but under the consolidant, they are only 20µm and flattened.</p> <p><i>Not foreseen in this case</i></p> <p><i>Not foreseen in this case</i></p>

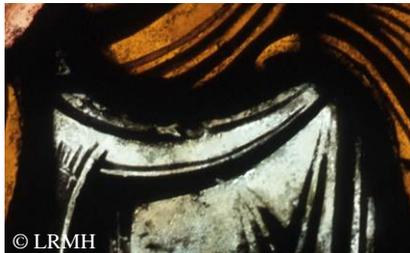
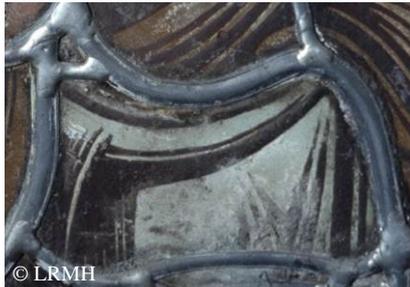
<p>© LRMH <i>Transmitted and reflected light</i></p>	<p>Optical Microscope</p> <p>SEM</p> <p>Desktop tomography</p>	<p>Most of the grisaille has a good shape on the glass. But on some areas, corrosion products are emerging on the glass and the paint. This phenomenon does not seem to take off the grisaille from its support. The corrosion products on the glass seem to peel: is it Viacryl® pushed away by alteration?</p>

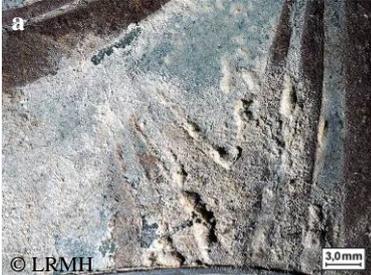
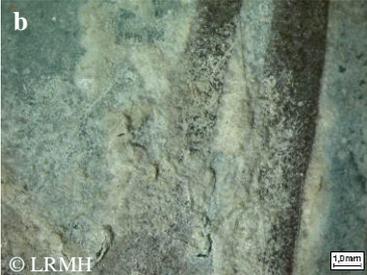
<p>a - corrosion products on glass and paint, proliferating preferentially on edges of paints. b - detail of the proliferation on glass and paint, and under Viacryl®.</p>

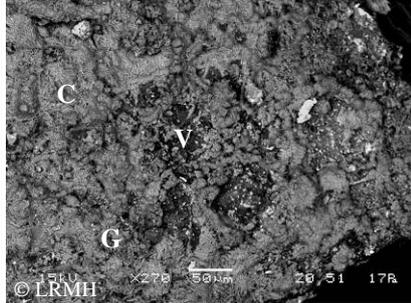
<p>Corrosion products with Viacryl® have been sampled on the glass. The neo-crystallisations of gypsum (C) are as little sticks (~10µm), between weathered glass (G) and Viacryl® (V). <i>Internal surface of Viacryl®-film: between film and glass.</i></p> <p><i>Not foreseen in this case</i></p>
