**CONSTGLASS**

Table of results

Ref. Parish Church south – Heraldic stained glass panel

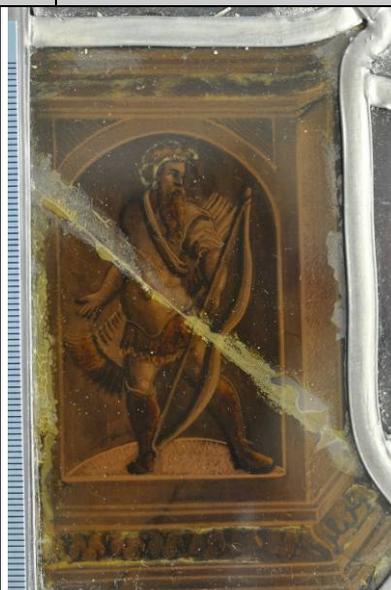
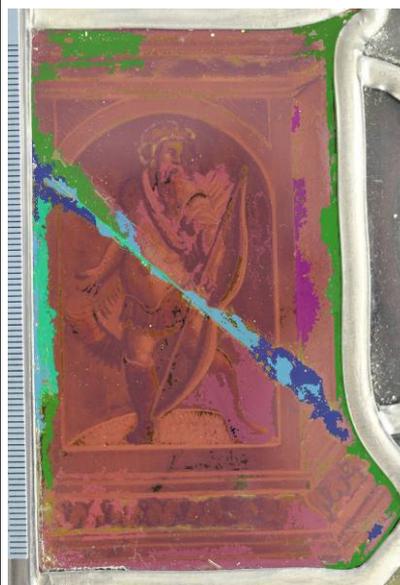
**Stage 1**

Clear and transparent resin, no or very little yellowing. The plated glass compound has a dark shining aspect, due to the intact adhesion of the filling material with both glass surfaces. There are no air bubbles or other structural changes.

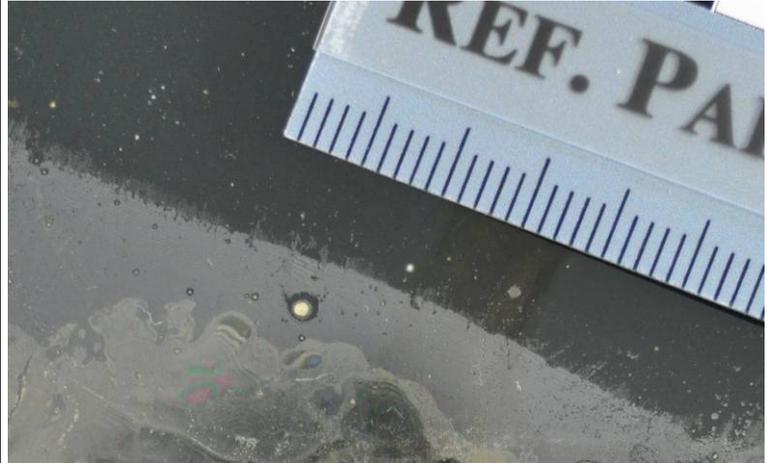
**Stage 5:**

Transparent detachment of the Araldite<sup>®</sup>, which looks grey-bluish in reflecting light. The filling resin starts to peel of from the smoother carrier glass but is still attached to the original glass surface. The compound can look less yellow in transparent light.

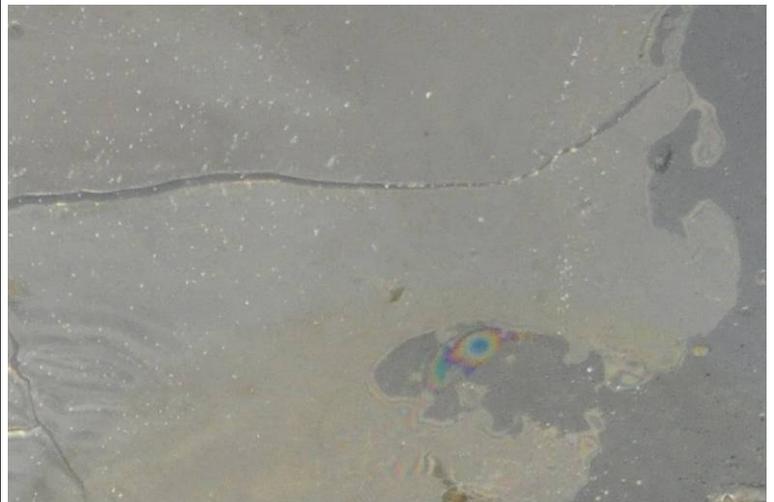
**Stage 6:**

The Araldite<sup>®</sup> takes an even brighter whitish aspect, “smoky” or “foggy”. The layer may have been shrinking. It seems to be detached from the old glass, but still adhering to the doubling glass.

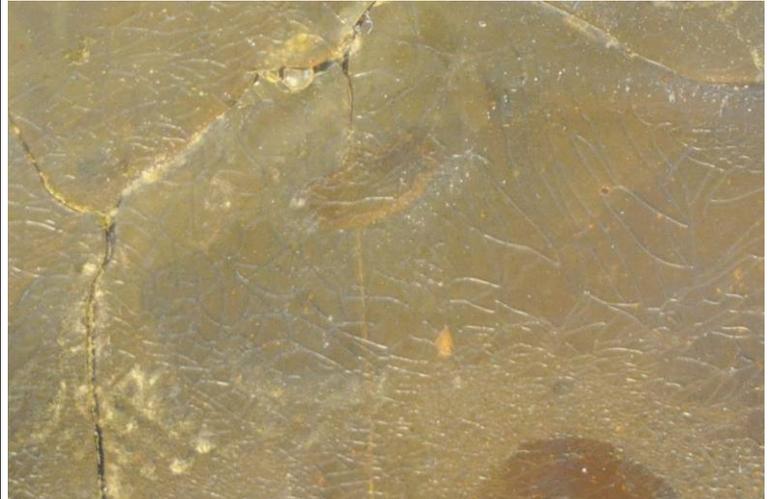
**Stage 7:**

The Araldite® looks golden, amber until ochre-yellow. The layer begins to break up, by lined-up cracks or flakes. It seems that at this step it has been detached from both glass surfaces.

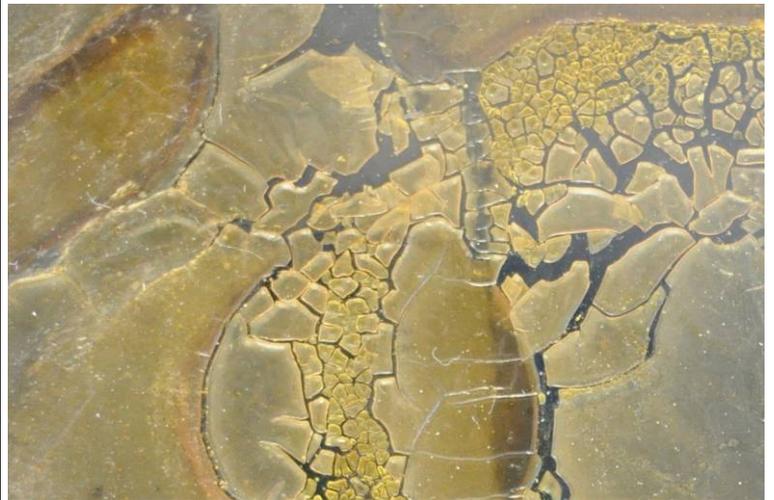
**Stage 8:**

Yellowed Araldite® with a shining whitish surface aspect looks therefore as detached from both surfaces. Broken up by cracks or flakes, also shrunken “flake-insulate” which can even overlap.

(Air bubble from process.)
