CONSTGLASS

Table of results

Canterbury Cathedral nII 7
Decorative border

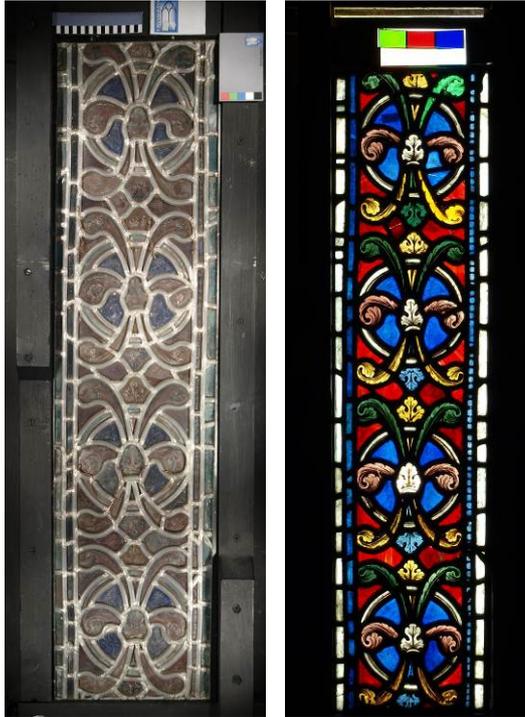
nII 7 internal face in transmitted and reflected light.

Product: Microcrystalline Wax no: 1129.

Application: Microcrystalline Wax diluted with white spirit.

Applied with a bush and mechanically polished.

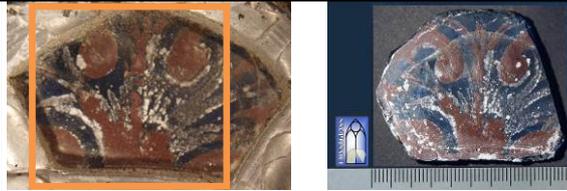
Questions	Techniques	Answers
<p>Morphology</p> <p><i>What is the physical appearance/condition of the wax?</i></p> <p><i>Has the wax penetrated into the surface of the glass?</i></p>	<p>Optical Microscope</p>	<p>The wax appears to be intact – mechanical polishing marks still visible. A light layer of accumulated dust on wax surface. Appears to remain transparent. Mild surface sheen when illuminated by reflective cold light. Paint appears solid and in good condition under the wax</p>
	<p>SEM</p>	<p>n/a</p>
	<p>Nano Tomography</p>

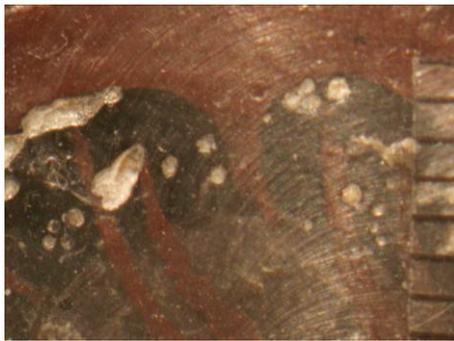
Wax coating under optical microscope before reversibility test

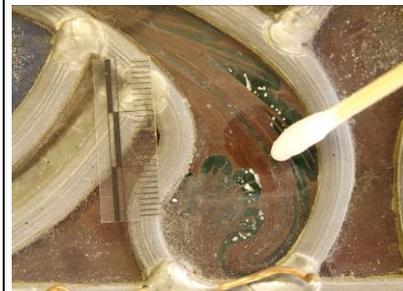
Cotton wool swabs: 30 seconds; 10 seconds using swab moistened with dichloromethane and a further 2 swabs to remove residue. White crystals formed on the surface of the swabs after their use. Is there a reaction to the cotton wool? Or has the solvent evaporated and left chlorine residue? Under magnification there appears to be no residue of the dichloromethane and no softening of the surrounding putty on the glass.

Reversibility test with dichloromethane swabs

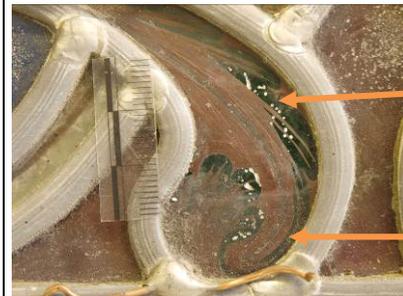
After test

Before test

Selected area for reversibility test

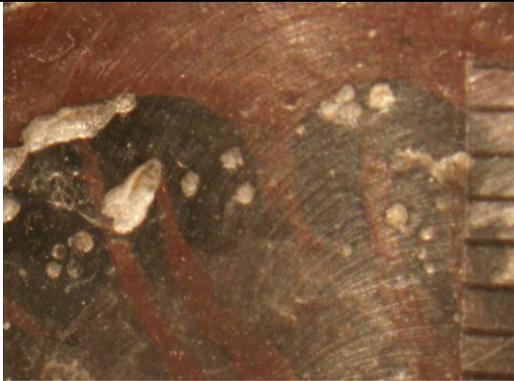
Before reversibility test in reflected light

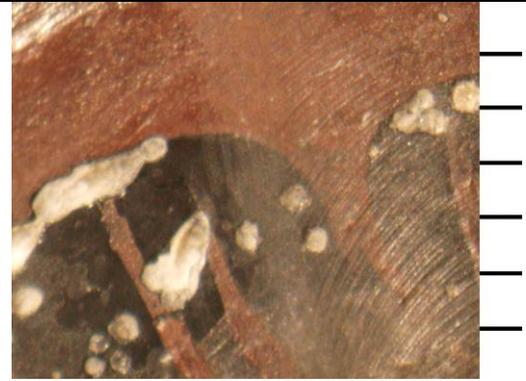
Results: removed the wax but left a slight residue, the absorbent pad formed white crystals after their use. Wax residue was removed with a swab moistened in dichloromethane.

After reversibility test on the left side
