CONSTGLASS

## 1-Pilot object

<b>Pilot object:</b>	Canterbury Cathedral NXVII 03	
<b>Picture</b>

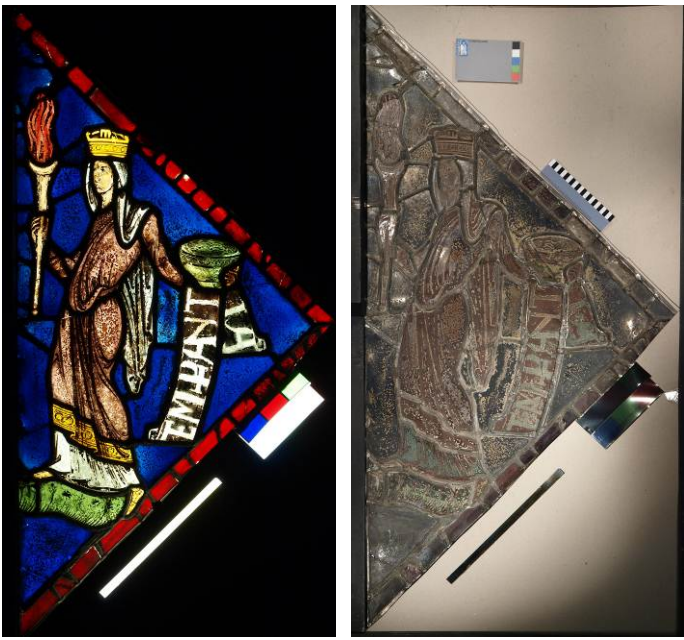
<p><b>Identification of the panel:</b> NXVII 03 internal face in transmitted and reflected light.</p> <p><b>Treatment:</b> <b>Product:</b> Microcrystalline wax no: 1129 and Polythene A Wax (unknown ratio); re-treatment with Paraloid® B72.</p> <p><b>Application:</b></p> <ul style="list-style-type: none"><li>• Wax applied with a brush in dilution with white spirit. Application of wax early to mid-1980s in situ as temporary consolidant of severely flaking painted decoration. No cleaning was carried out prior to application of wax. The wax was not polished (unlike CAN nII 7). Window remained unprotected until 1992.</li><li>• Re-treatment with Paraloid® B72 in 1992.</li><li>• Fractures bonded with Silicone Rhodia® CAF 3 in 1992.</li></ul>

<b>Reversibility</b>	<b>Test studies Elimination</b>	The wax coating was removed mechanically with scalpels under optical microscope in 1992. Where adhesion was good the wax coating was thinned down mechanically, but not completely removed. No new reversibility test was carried out in 2009, as the unstable condition of the painted decoration was of concern.
<b>Re-treatability</b>	<b>Test studies Re-treatability</b>	Paraloid®-B2 in acetone dilution was applied in 1992 to consolidate flaking paint. This was often applied onto remaining wax coatings. Application of Paraloid®-B72 with brush. Easy application and good immediate adhesion.
