CONSTGLASS

Table of results

Canterbury Cathedral NXVII C1

CAN NXVII C1

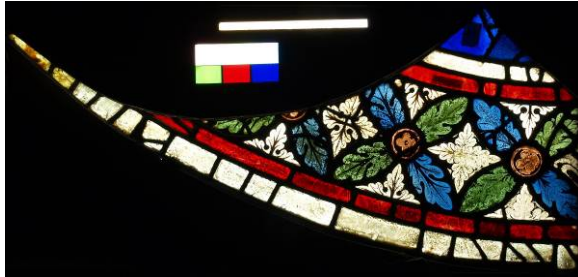
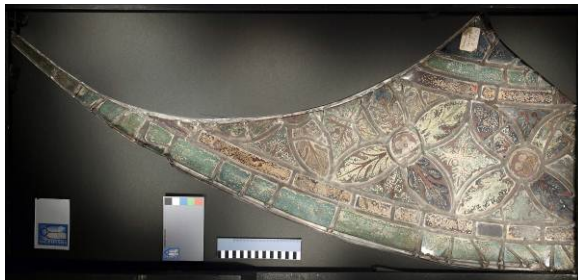
Identification of the panel:

NXVII C1 internal face in transmitted and reflected light

The panel was used as a test panel for a pilot study on paint consolidation by the Fraunhofer Institut Silicatforschung. Three different consolidation materials have been used on separate glass pieces within the panel: SZA, Ormocer®/Paraloid® B72 1/1 and Paraloid® B72.

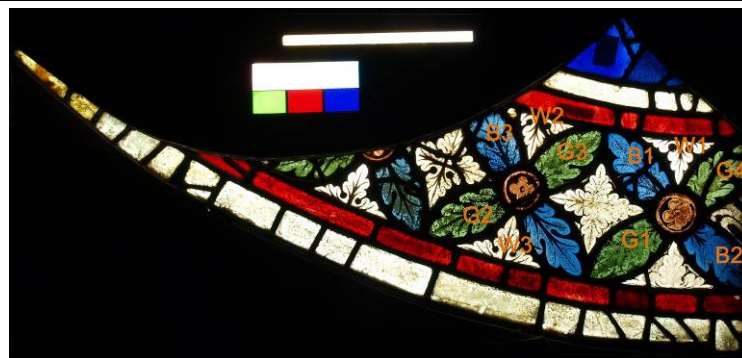
Numbering system:

B1, G1, G4 and **W2** tested with SZA,

B2, G2, and **W1** tested with Ormercer® and Paraloid B72,®

B3 and **G3** tested with Paraloid® B72.
