CONSTGLASS

Table of results

<b>Pilot object:</b>	Canterbury Cathedral S VII 4 Decorative border	
<b>Picture</b>

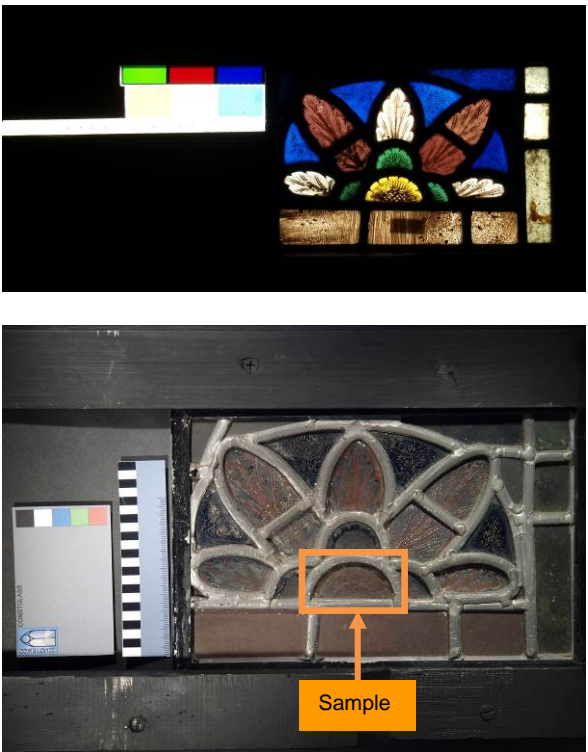
<b>Identification of the panel:</b> S VII 4 internal face in transmitted and reflected light  <b>Treatment:</b> <b>Product :</b> Microcrystalline Wax no:1129 and Polythene A Wax (unknown mixture quantities); <b>Application:</b> Wax diluted with white spirit. Applied with a brush and mechanically polished.

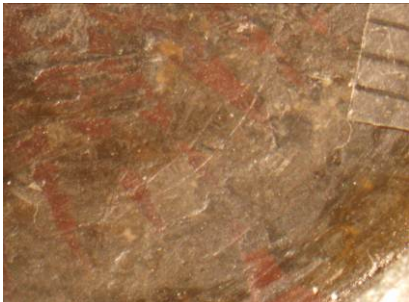
<p>Surface of wax under reflected light</p>	<b>Optical Microscope</b>	The wax appears to be intact – mechanical polishing marks still visible. A light layer of accumulated dust on wax surface. Appears to remain transparent. Mild surface sheen when illuminated by reflective cold light. Paint appears solid and in good condition under the wax.
	<b>SEM</b>	
	<b>Nano tomography</b>	
	<b>Tomography on Synchrotron</b>	
<b>Chemical Composition</b>	<b>SEM</b>	
<b>Organic component composition</b>	<b>FTIR</b>	
	<b>RAMAN</b>	
<p><b>Microbiology</b></p> <p><i>Is there/ has there been any microbial activity on the wax surface?</i></p>	<b>Molecular biology ATP measurements</b>	Very low levels of fungal spores detected, no typical micro flora for historic glass, very low metabolic activity. No significant difference between archive storage and in situ.

<b>Reversibility</b>	<b>Test studies Elimination</b>	
<b>Re-treatability</b>	<b>Test studies Re-treatability</b>	No need. No treatment recommended.
