**CONSTGLASS**

Table of results

*The Typological Passion*, CHARTRES  
Bay 37, panel 16

**Sample reference:** *CHA\_b37p16\_I\_v2 : white glass, coated on internal surface (consolidation)*

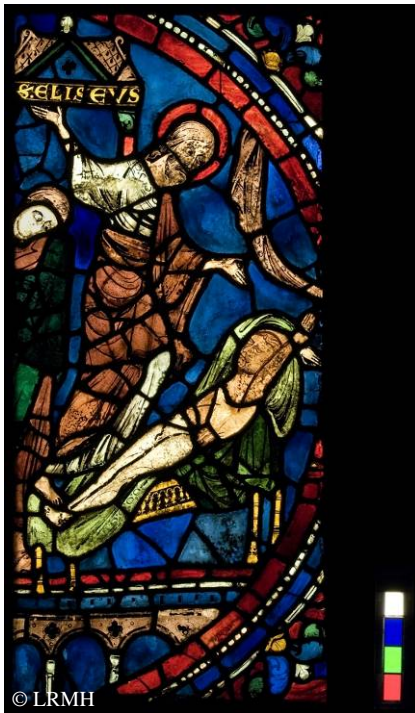
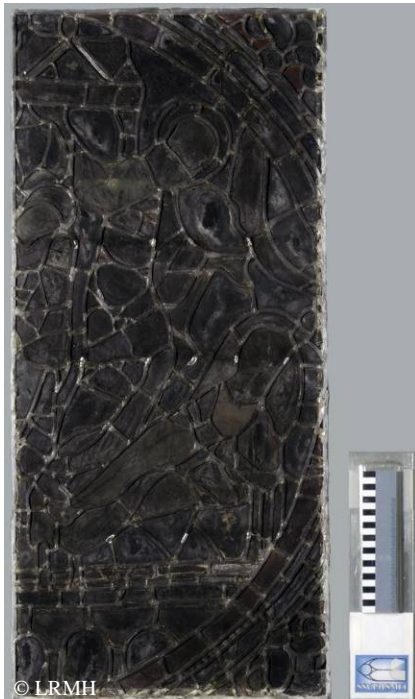
Bay: 37  
Panel: 16  
Internal face, transmitted light  
Internal face, reflected light

- 1988, by Alliou studio.
- Product: polyurethane resin (80% Viacryl® SM564 + 20% Desmodur® N75).
- Application: with a soft brush after cleaning.

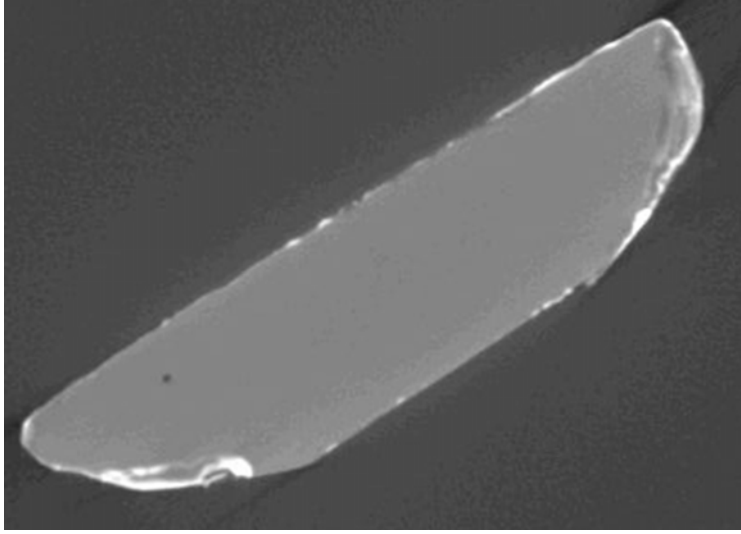
<p style="text-align: right;">After re-treatment</p> <p>As on the sample v2, desktop tomography did not provide information on the re-treatment. A doping of Paraloid® was tried in order to see it on the sample, but then it is hard to distinguish the polymer from the grisaille.</p>
