CONSTGLASS

Table of results

1- Pilot Object

Pilot object:	The <i>Typological Passion</i> , CHARTRES Bay 37, panel 44	
Picture

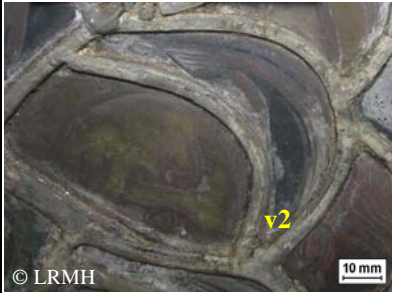
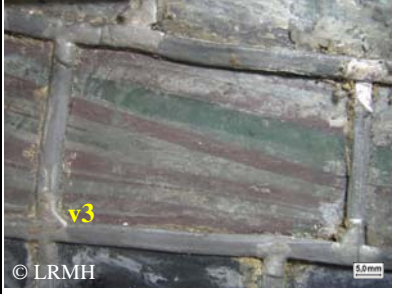
<p>Optical Microscope</p>	<p>Difficult to see Viacryl®: only excess on the edges of paint are visible with microscope. They have a lumpy and sometimes a brilliant aspect, but no macro-cracks, no yellowing or milky aspect.</p>
