CONSTGLASS

Table of results

The death and assumption of the Virgin, CHARTRES
Bay 42, panel 21

Sample reference: *CHA_b42p21_I_v1: yellow glass with Viacryl® consolidation on internal surface*

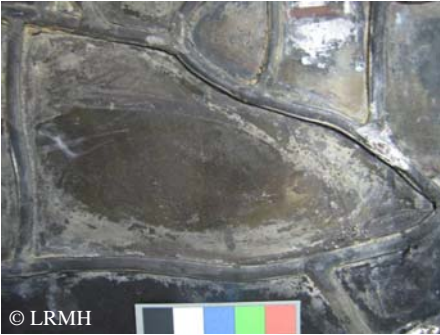
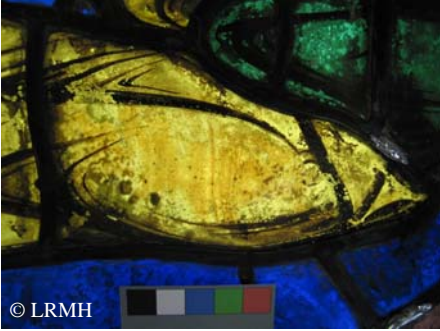
<p>© LRMH</p> <p>White rectangle locate the optical microscope observations</p>	<p>Optical Microscope</p>

<p>© LRMH</p> <p>© LRMH</p> <p><i>Detail of internal face, reflected and transmitted light. It is covered by dust and corrosion products, which makes difficult to observe Viacryl® consolidant. On this area, the gaps of grisaille are due to bubbles, probably caused by too much baking. But the rest of the paint seems to be safe.</i></p>

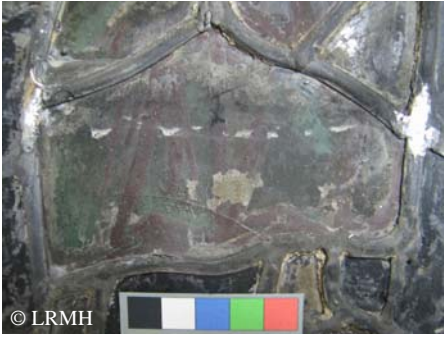
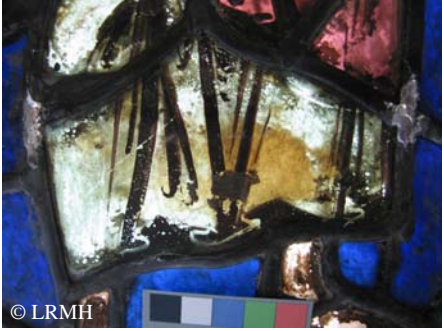
Sample reference:	<i>CHA_b42p20_I_v5: brown glass with Viacryl® consolidation on internal surface</i>
--------------------------	---

<p>© LRMH</p> <p>White rectangle locate the optical microscope observations</p>	<p>Optical Microscope</p>

<p>© LRMH</p> <p>© LRMH</p> <p>© LRMH</p>	<p><i>Detail of internal face, reflected and transmitted light. Same phenomenon as sample v4 and most of the pieces of this panel: the superficial layer of glass is gone, taking with it the grisaille.</i></p> <p><i>Detail of glass paint, reflected light. It is covered by dust and corrosion products, which makes difficult to observe Viacryl® consolidant. On this area, the gaps of grisaille are due to bubbles, probably caused by too much baking. But the rest of the paint seems to be safe.</i></p>
	<p>SEM</p>	<p><i>Not foreseen in this case: sample hasn't been unstopped.</i></p>
