CONSTGLASS

1-Pilot object

Pilot object: Cologne Cathedral,
N VI, choir clerestory, "Cycle of Kings" (ca. 1300)

Panel: 4bl
external face

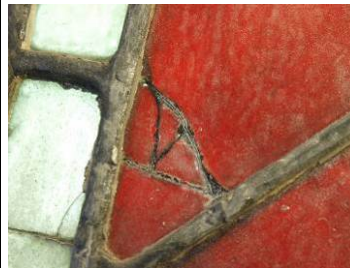
sample Col_ORMOCER

sampling area (external face)

(The above pictures show the complete sample, that was afterwards divided in separated pieces)

<p data-bbox="100 427 209 456">Remarks</p>	<p data-bbox="767 427 1497 611">The external surface of the panel is completely coated with the ORMOCER[®] protective system. The coating is in a good condition. Here and there bubbles are visible and several parts of the coating (thick application) have a milky aspect. The putty around the glass pieces was coated with ORMOCER[®], too. From the conservator's point of view there is no need to remove the coating.</p>

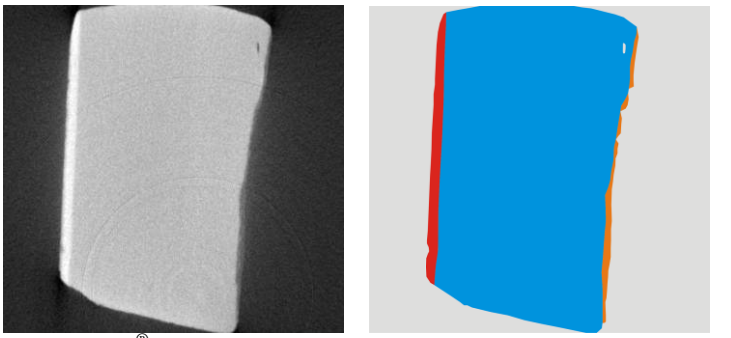
<p>ORMOCER[®] coated sample (treatment 1988): Code for the left picture: on the left: red flashed glass layer, in the middle: bulk glass, on the right: ORMOCER[®] protective layer with glass flakes. Colour code for right picture: blue area is bulk glass, the red area is the red flashed glass and the orange area is the ORMOCER[®] coating.</p>
	Phase-contrast tomography on Synchrotron (Institute)	not foreseen
	SEM/EDX (Institute)	n/a (before re-treatment with Paraloid [®])
Organic component composition	FTIR (Institute)	n/a (before re-treatment with Paraloid [®])
Microbiology	RAMAN (FCS)	n/a (before re-treatment with Paraloid [®])

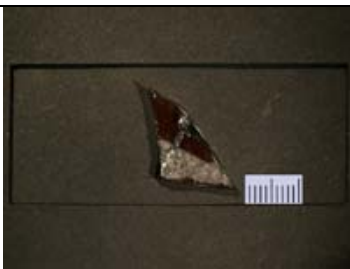
<p>sample retreated with Paraloid® B72 (doped with Sartomer® for μCT)</p>

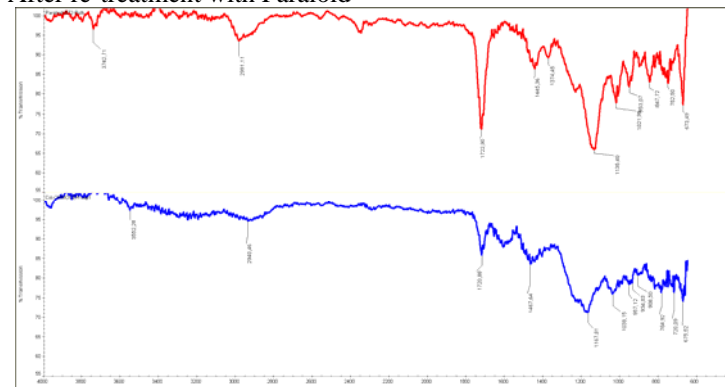
The Col_ORMOCERe_separated_1 spectra (blue) - measured at the top of the re-treated area - is comparable with a Paraloid[®] B72 reference spectrum, upper one in red colour.

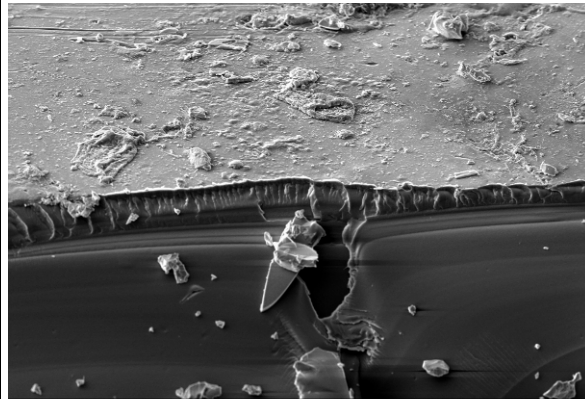
10 µm Vergrößerung = 1.50 KX Signal A = SE1 Name = MAA57
Arbeitsabstand = 7.0 mm Hochsp. = 8.05 kV Dateiname = P201-08.tif
Datum = 17. Mai 2010 Sample ID = Col-ORMOCER-se2

SEM picture: The ORMOCER[®] shows, even after the exposure a good adhesion to glass. No fissures between glass and ORMOCER[®] are detectable. The embedded glass flakes are almost covered by the ORMOCER[®] and Paraloid[®].

SEM picture with higher magnification.

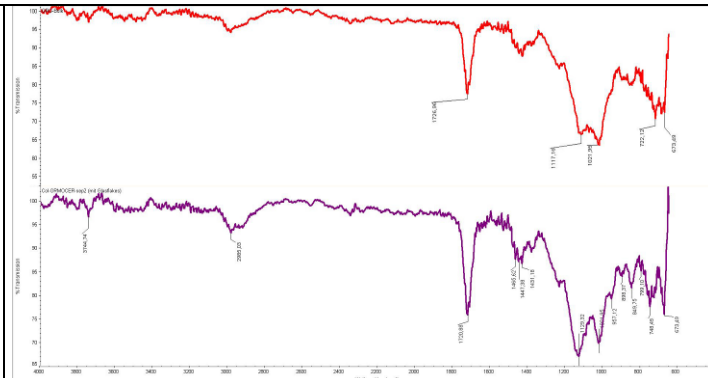
ORMOCER[®] bulk material as reference (red line) in comparison to Col_ORMOCERe_sep_2, several layers of ORMOCER[®] (applied 1991)
