CONSTGLASS

Table of results
Klausen

Klausen, Parish Church

I, choir, axial window, "Crucifixion and Flight to Egypt" (1878)

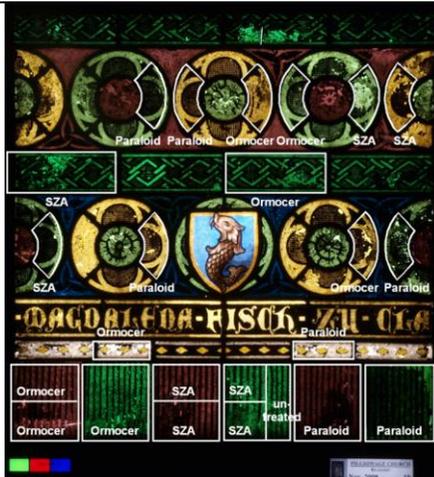
Panel: 1b
internal face

The last conservation campaign took place in 1991, carried out by a commercial workshop. In the course of this campaign the investigated panel was chosen as a test object for paint-layer consolidation (fired and unfired paint). The stained glass studio of Cologne Cathedral made tests with three different materials for the sake of comparison:

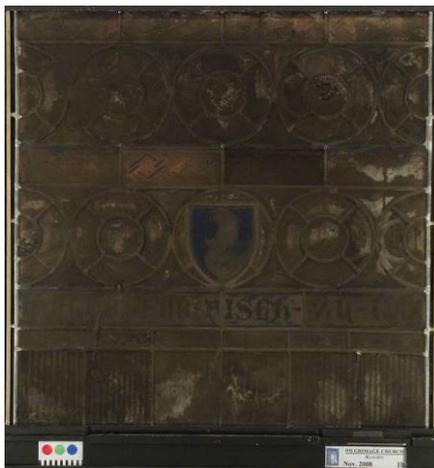
- with a soft brush, no preceding cleaning of the surface.
- the application was carried out in the marked areas. Mainly the contours were treated. Some areas were completely covered.

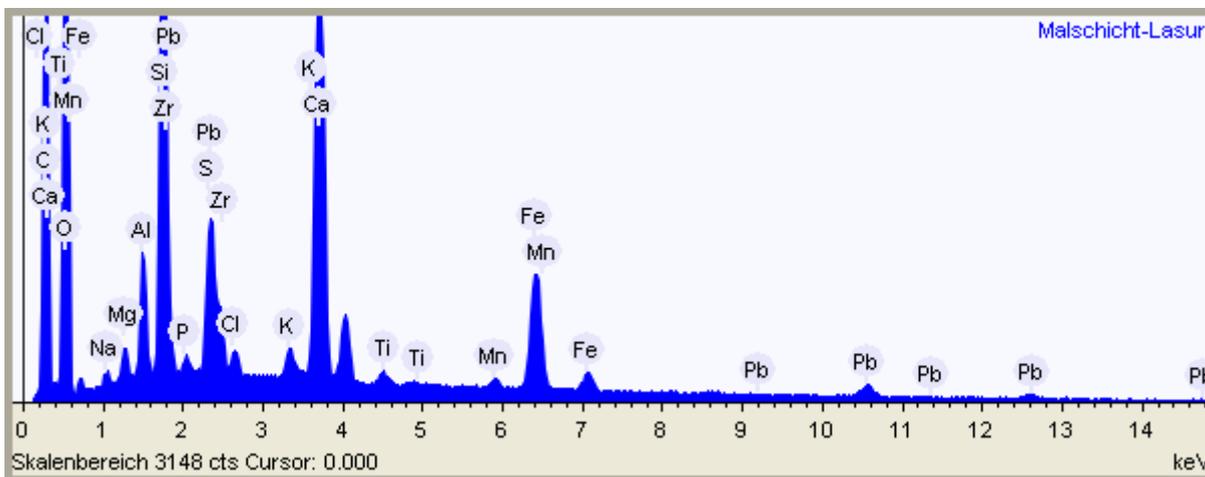
Analyse of paint layer / glaze:

Element	weight%	weight % σ	atom %
Carbon	36.210	0.360	49.820
Oxygen	39.023	0.302	40.307
Sodium	0.199	0.028	0.143
Magnesium	0.338	0.023	0.230
Aluminium	0.997	0.027	0.611
Silicon	5.258	0.056	3.094
Phosphor	0.113	0.025	0.060
Sulphur	0.782	0.035	0.403
Chloride	0.246	0.024	0.115
Potassium	0.306	0.025	0.129
Calcium	7.648	0.074	3.154
Titan	0.215	0.030	0.074
Manganese	0.338	0.041	0.102
Iron	4.946	0.083	1.464
Zirconium	0.252	0.072	0.046
Lead	3.130	0.126	0.250

Various components are found in proportions difficult to interpret. Main elements: carbon, oxygen, silicon, calcium, iron and lead – it is not possible to distinguish clearly fired paint layer (inorganic), unfired paint (probably organic and inorganic), dust (organic and inorganic) and conservation material (pure organic). In comparison to the spectra taken at the reference sample and the sample treated with SZA more carbon is detected – this might be a hint for the presence of ORMOCER®.

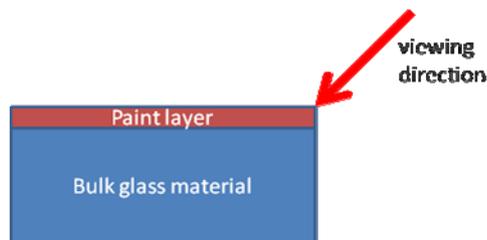
Broken glass fragment. The roughness of the thin paint layer is very good observable in the upper part of the picture. In the lower part the glass bulk material is visible. The picture was taken in a perspective view, see scheme below.

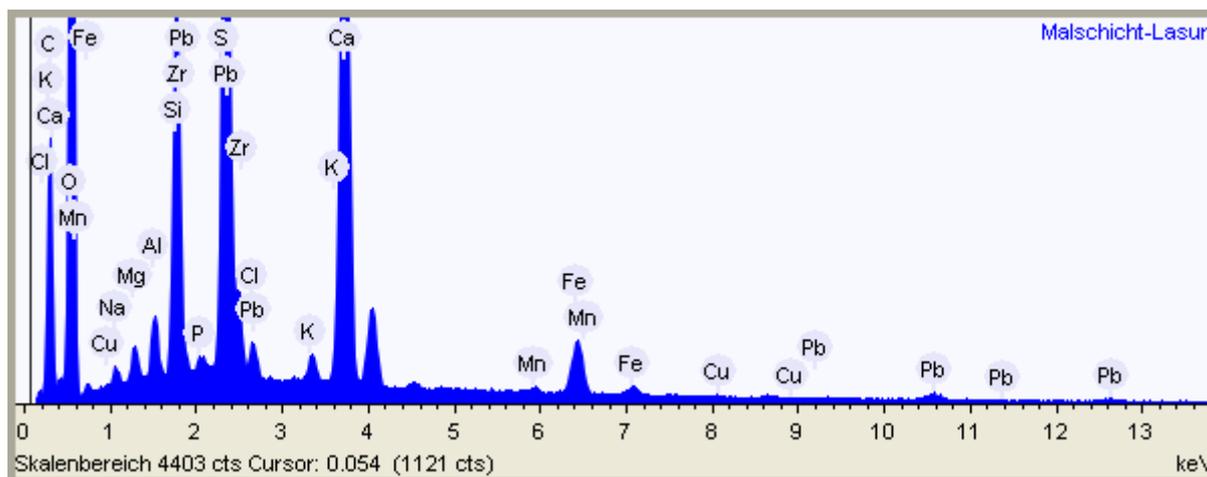
Analysis of paint layer / lasur:

Element	weight%	weight% σ	atom%
Carbon	24.407	0.321	35.691
Oxygen	47.350	0.276	51.980
Sodium	0.285	0.029	0.217
Magnesium	0.382	0.022	0.276
Aluminium	0.534	0.021	0.347
Silicon	3.372	0.039	2.109
Phosphor	0.001	0.023	0.001
Sulphur	6.235	0.059	3.416
Chloride	0.407	0.024	0.201
Potassium	0.377	0.022	0.170
Calcium	10.098	0.077	4.425
Manganese	0.160	0.033	0.051
Iron	2.290	0.055	0.720
Copper	0.001	0.052	0.000
Zirconium	0.445	0.068	0.086
Lead	3.655	0.156	0.310

The spectrum is again very difficult to interpret due to the fact of the mix of dirt, cold paint (organic and inorganic), fired paint (inorganic) and conservation material (inorganic). Mainly organic components are detected and corrosion products containing sulfur and calcium.

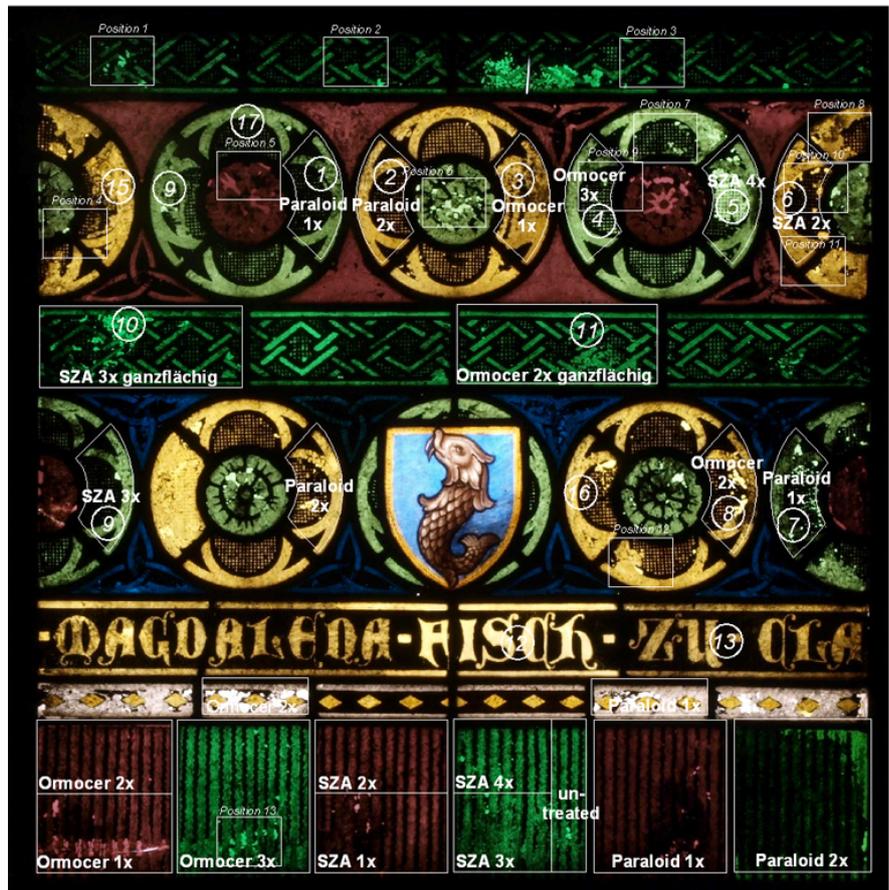
The investigations took place on the whole panel not only on Kla_SZA_1

○ = Materialproben ATP Stick Okt. 2009, LWB (Wiederholung an 1, 3, 6, 10, 11, 15 Mai 2010, DBH)

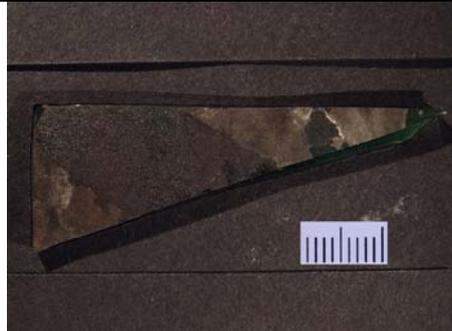
retreated with Paraloid® B 72 (doped)

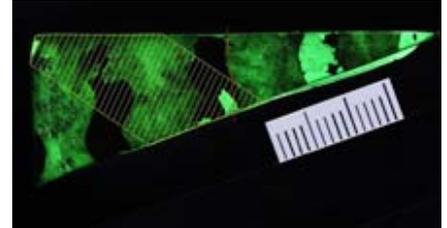
treated area is marked with yellow scratches

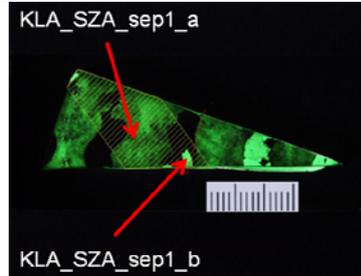
Measuring areas on the re-treated sample.

Kla_SZA_separated_1_a was performed on the paint layer, Kla_SZA_separated_1_b on an area where the paint layer was damaged.

The two measured spectra are similar to Paraloid® B72, measured as a reference on bulk material. Also the damage area was coated with Paraloid® B72. The underneath paint layer has no influence on measuring (organic) spectra with ATR-FTIR, compare Kla_SZA_separated_1-a and Kla_SZA_separated_1-b.

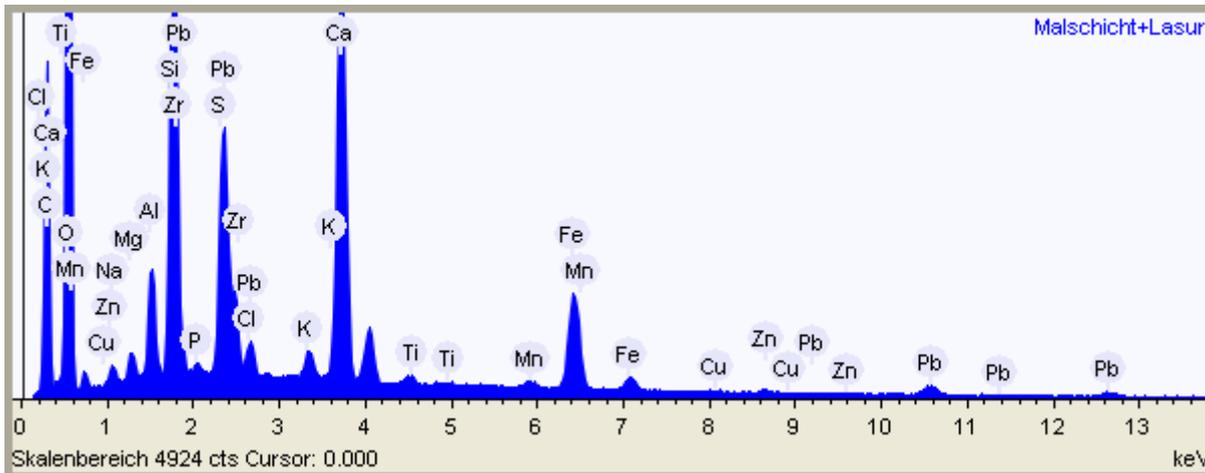
SEM/EDX analyse of painting-glazing:

Element	weight%	weight% σ	atom%
Carbon	27.406	0.354	40.096
Oxygen	43.498	0.285	47.776
Sodium	0.291	0.033	0.222
Magnesium	0.348	0.022	0.251
Aluminium	1.116	0.026	0.727
Silicon	5.936	0.055	3.714
Phosphor	0.085	0.023	0.048
Sulphur	2.036	0.041	1.116
Chloride	0.422	0.025	0.209
Potassium	0.426	0.023	0.192
Calcium	7.755	0.068	3.400
Titan	0.190	0.027	0.070
Manganese	0.245	0.036	0.078
Iron	4.849	0.074	1.526
Copper	0.146	0.057	0.040
Zink	0.386	0.071	0.104
Zirconium	0.162	0.067	0.031
Lead	4.704	0.139	0.399

Both spectra show similar results despite the fact that the first one was taken on a trace line in an area with less or no cold paint and the second spectra was taken in an area where mainly not fired paint was expected. The mix of various materials can hardly be distinguished and clearly be identified.

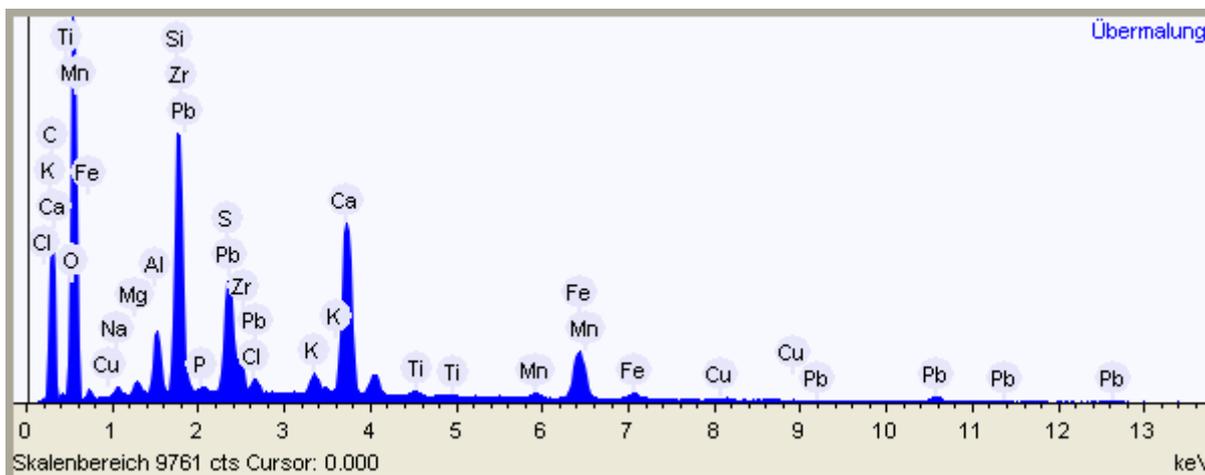
SEM/EDX analyse of not fired paint :

Element	weight%	weight% σ	atom%
Carbon	28.670	0.362	41.218
Oxygen	43.766	0.291	47.237
Sodium	0.343	0.031	0.258
Magnesium	0.345	0.023	0.245
Aluminium	1.315	0.028	0.841
Silicon	5.800	0.056	3.566
Phosphor	0.108	0.023	0.060
Sulphur	2.039	0.041	1.098
Chloride	0.360	0.024	0.175
Potassium	0.529	0.026	0.234
Calcium	6.603	0.063	2.845
Titan	0.265	0.028	0.096
Manganese	0.395	0.038	0.124
Iron	4.984	0.076	1.541
Copper	0.382	0.061	0.104
Zirconium	0.157	0.067	0.030
Lead	3.939	0.136	0.328
