**CONSTGLASS**

Table of results

The *Crowning Virgin and the 12 apostles*, LE MANS  
Bay XVI, panel 10

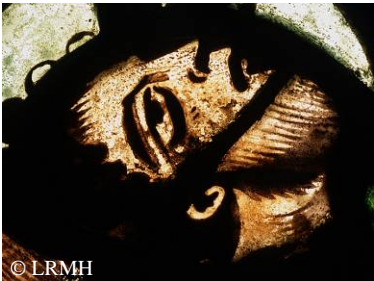
<p>© LRMH <i>Transmitted light, internal surface</i></p>

<p><b>a</b> – Viacryl® on glass and grisaille. It's flaking where corrosion has restarted. <b>b</b> - Detail of the Viacryl® delamination on glass corrosion products</p> <p>Most of the grisaille has a good shape on the glass. But on some areas, corrosion products are emerging on the glass and the paint, pushing away the Viacryl®. It is hard to say if this phenomenon takes off the grisaille from its support.</p>
	<p><b>SEM</b></p>

<b>Reversibility</b>	<b>Test studies Elimination</b>	<p>The restoration has been made in 2005 by Pivet studio (Morthemer, 86). N-methyl-2-pyrrolidone has been used to remove corrosion products and Viacryl® on glass in internal surface.</p>

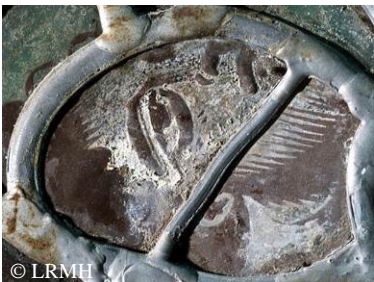
<p>© LRMH <i>Reflected light, internal surface</i></p>	<p><b>Optical Microscope</b></p>
