CONSTGLASS

Table of results

The *Crowning Virgin and the 12 apostles*, LE MANS
Bay XVI, panel 11

Sample reference: *CHA_bXVIp11_E_v5 : red glass, coated with Viacryl® on external surface*

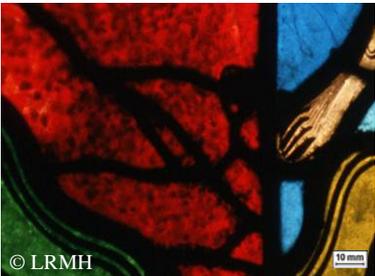
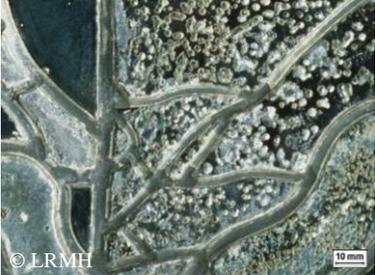
<p>© LRMH</p> </div> </div> <p><i>Transmitted light, internal surface</i></p> <p><i>Reflected light, external surface</i></p>	<p>Optical Microscope</p>	<div style="display: flex; justify-content: space-around;"> <div style="text-align: center;">

<p>© LRMH</p> </div> </div> <p><i>a – Viacryl® flakes in glass craters. b - Detail of the glass surface.</i></p> <p>On most of the pieces, Viacryl® has been washed away by rain and wind. Here, a large part is still in the craters: we can see the film has been retracted when hardened, it is yellowing and has a milky aspect. A large part of healthy glass is bared (brilliant aspect).</p>

<p>Reversibility</p>	<p>Test studies Elimination</p>	<p><i>Not foreseen in this case, see sample v3</i></p>	
<p>Re-treatability</p>	<p>Test studies Re-treatability</p>	<p>No re-treatability was recommended. An external protective glazing was installed in 2008, by Debitus studio (Tours, 37).</p>

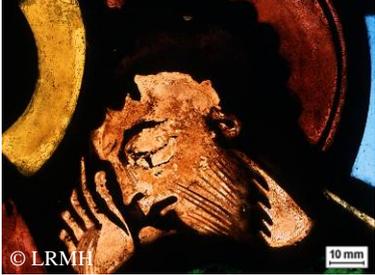
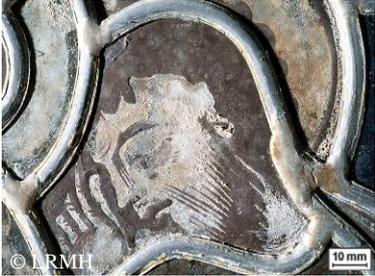
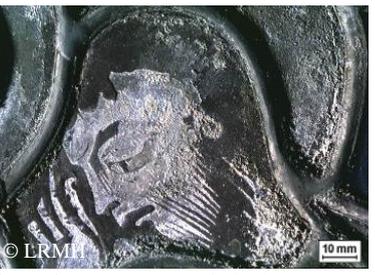
<p><i>Viacryl® on grisaille (G) and glass. It's flaking where corrosion (C) has restarted (particularly on glass).</i></p> <p>© LRMH</p>

<p>© LRMH 10 mm</p> <p><i>Transmitted light, internal surface</i></p>

<p>© LRMH 10 mm</p> <p><i>Reflected light, internal surface</i></p>

<p>© LRMH 10 mm</p> <p><i>Before the restoration of 1974</i></p>	<p>SEM</p>

<p>© LRMH</p>	<p>The restoration has been made in 2005 by Pivet studio (Morthemer, 86). N-methyl-2-pyrrolidone has been used to remove corrosion products and Viacryl® on glass in internal surface.</p> <p>Viacryl® and most of corrosion products have been cleaned, the grisaille is still in a good state of conservation.</p>
Re-treatability	Test studies Re-treatability	<p>No re-treatability was recommended. An external protective glazing was installed in 2008, by Debitus studio (Tours, 37).</p>
