**CONSTGLASS**

Table of results

Ref. Parish Church south – Heraldic stained glass panel

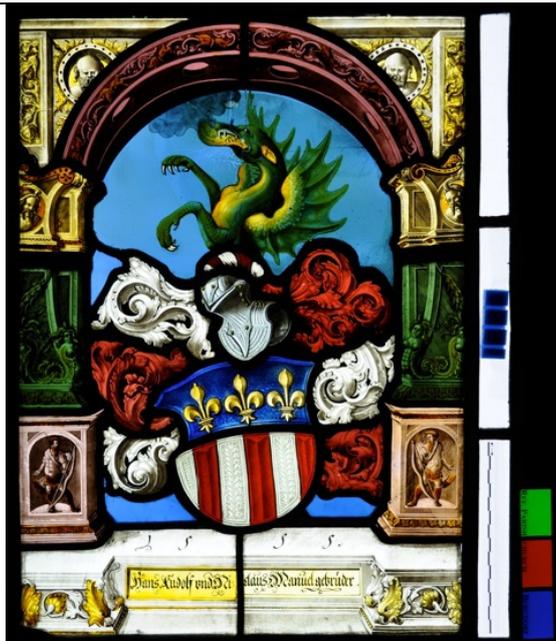
**Picture**

*Panel of fragments*

*Internal face, transmitted light*

*External face, reflected light*

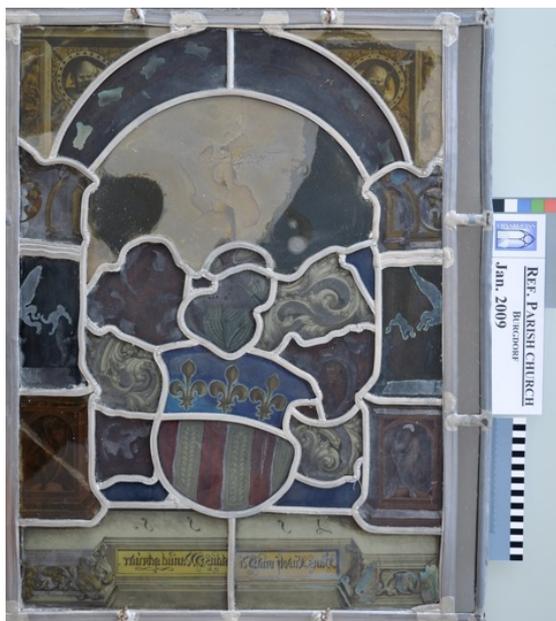
- 1971, by Konrad Vetter
- Araldite® binder AY103 by 100 parts,  
Hardener HY951 by 9 parts  
(Astorit AG 8840 Einsiedeln).
- For thin fragments (1-1.5mm) with multiple fractures,  
the simple edge bonding was not considered to be  
sufficient and the method of back-plating was used.
